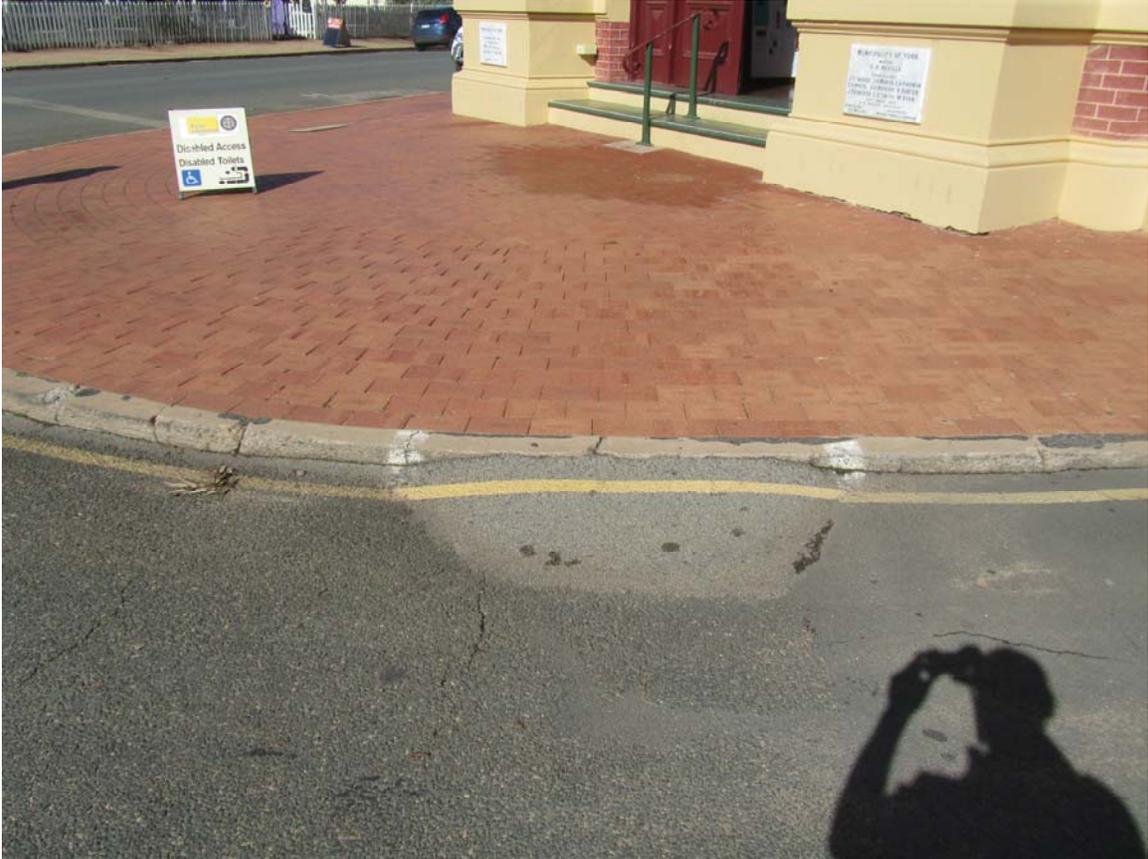
The ramp above is approx 9 meters away from Avon Terrace. Persons using this ramp cannot see if any cars are approaching from the South. They currently cross the road here and hope for the best. The ramp is designed in such a manner that is dangerous if not driven down the center of the ramp and users have nearly rolled their gophers and wheelchairs. The ramps is not compliant with current standards.

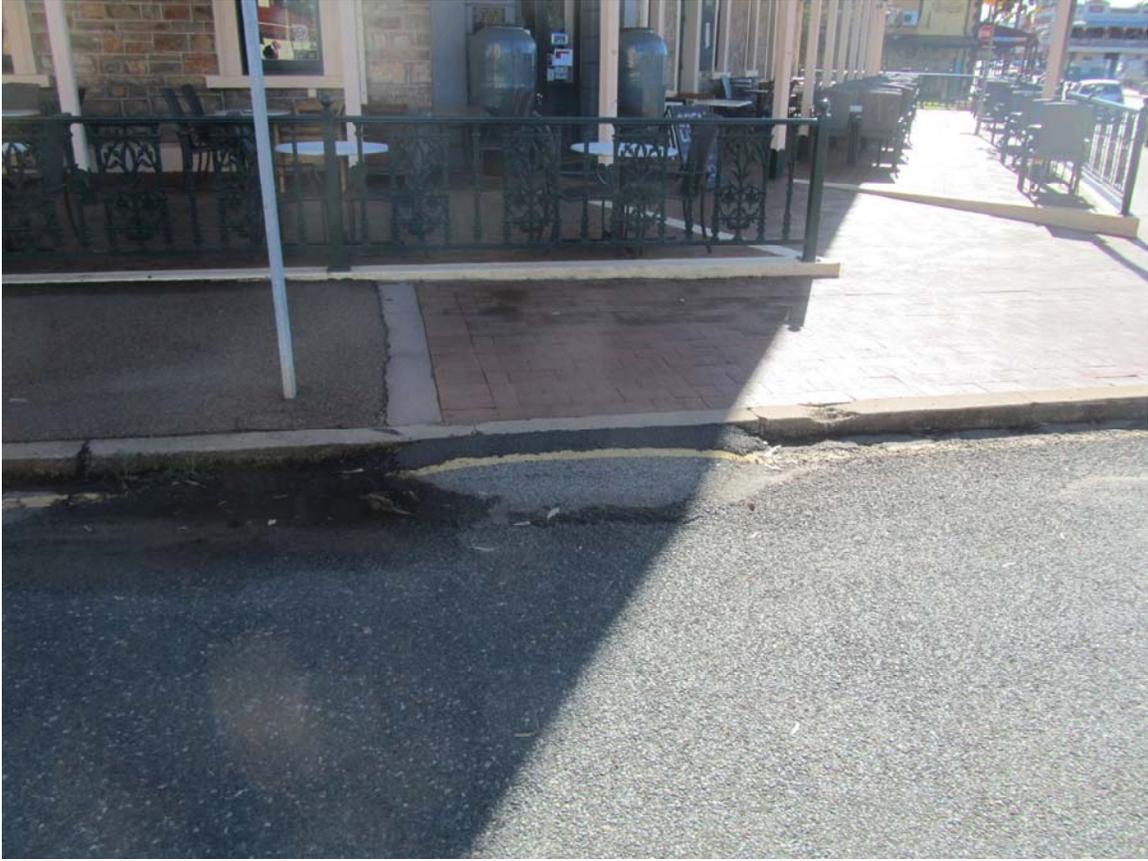
This ramp outside the Imperial does not line up with the ramp outside the Town Hall and is approx 6 meters from Avon Terrace. It is also of poor design and non compliant.

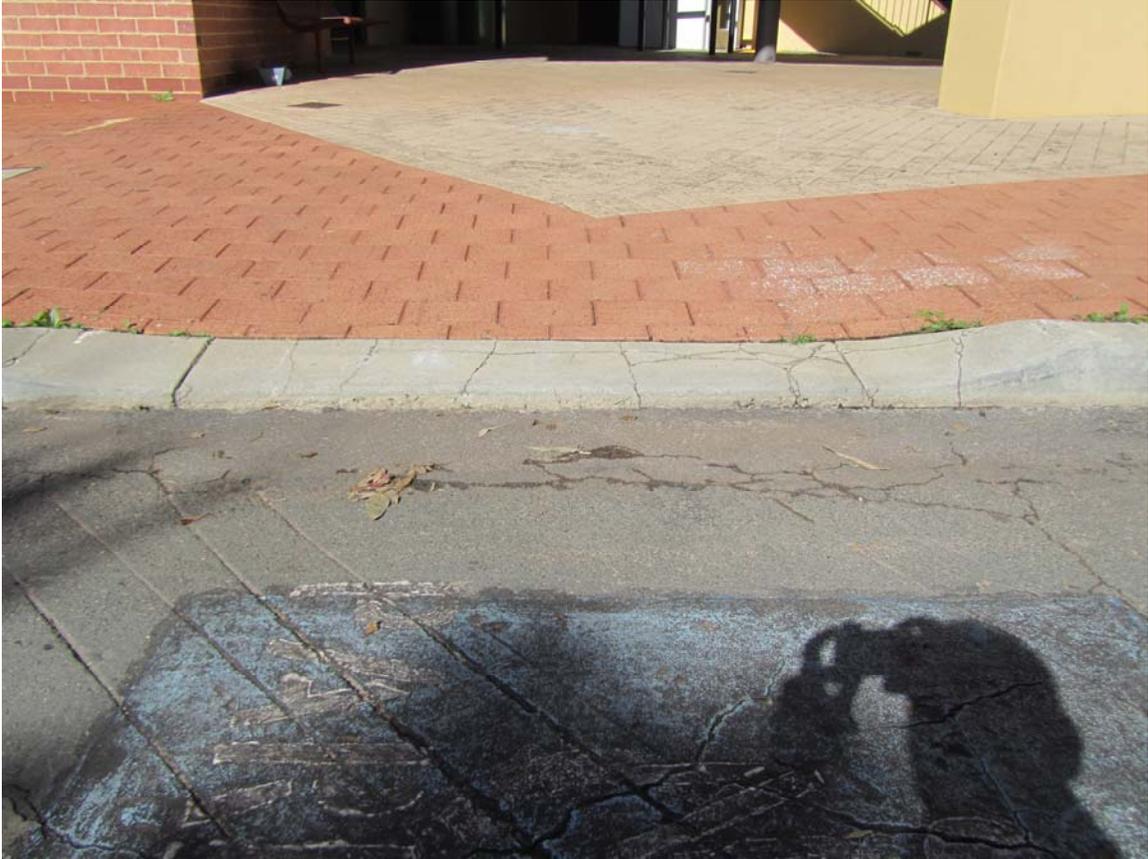
The ramps outside the shire office have a lip of approx 50mm and the rear anti roll wheels on a wheelchair get stuck on a lip of this height.

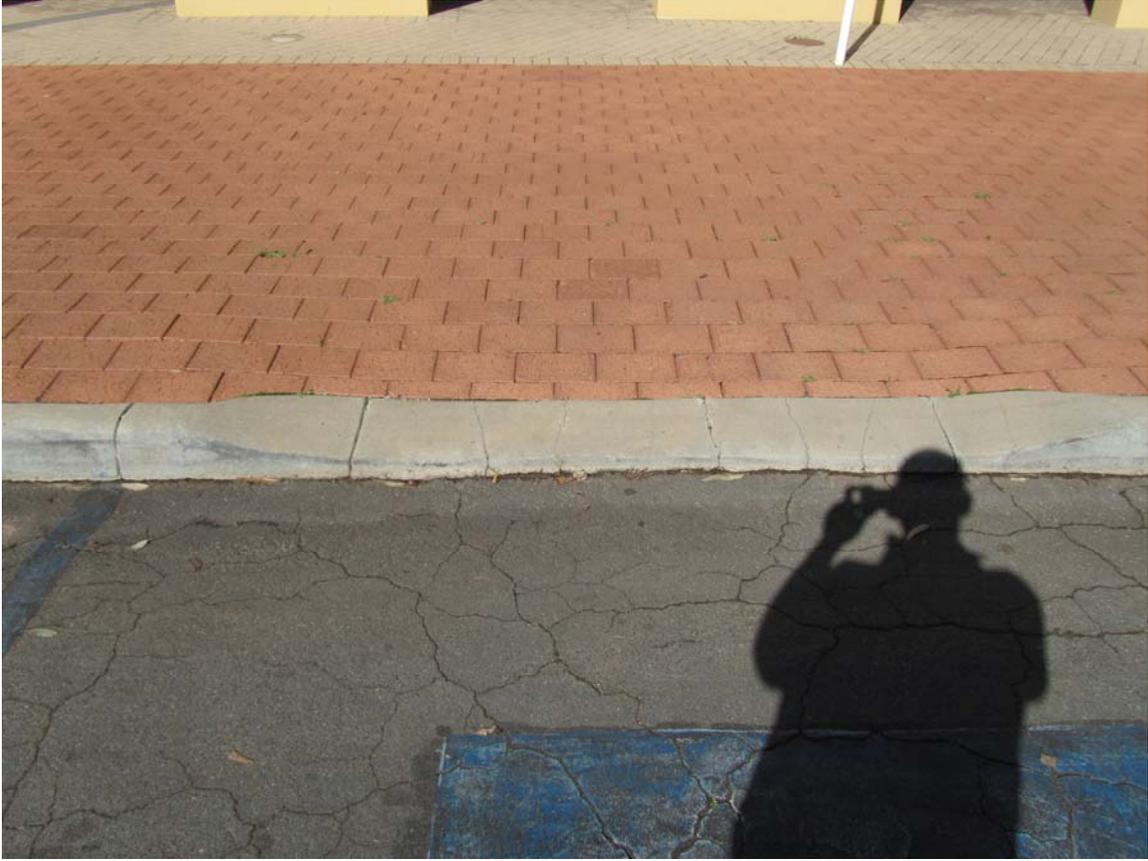
The same lip can be seen here. The disabled bays need to be cut deeper into the footpath to allow users to get their wheelchairs off their cars without being in the path of traffic.

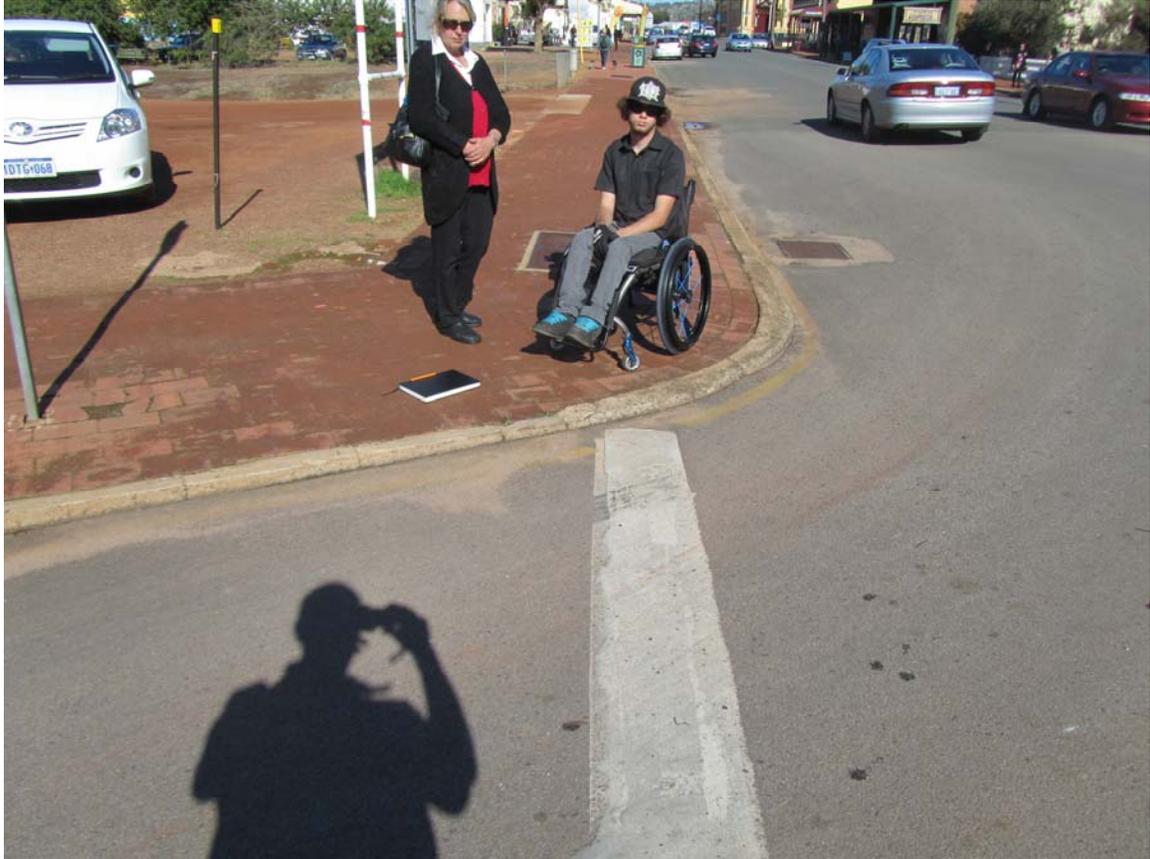
No ramp is here at all. The foot path in the background between Smiths garage and here is uneven in many place and has numerous trip hazards.

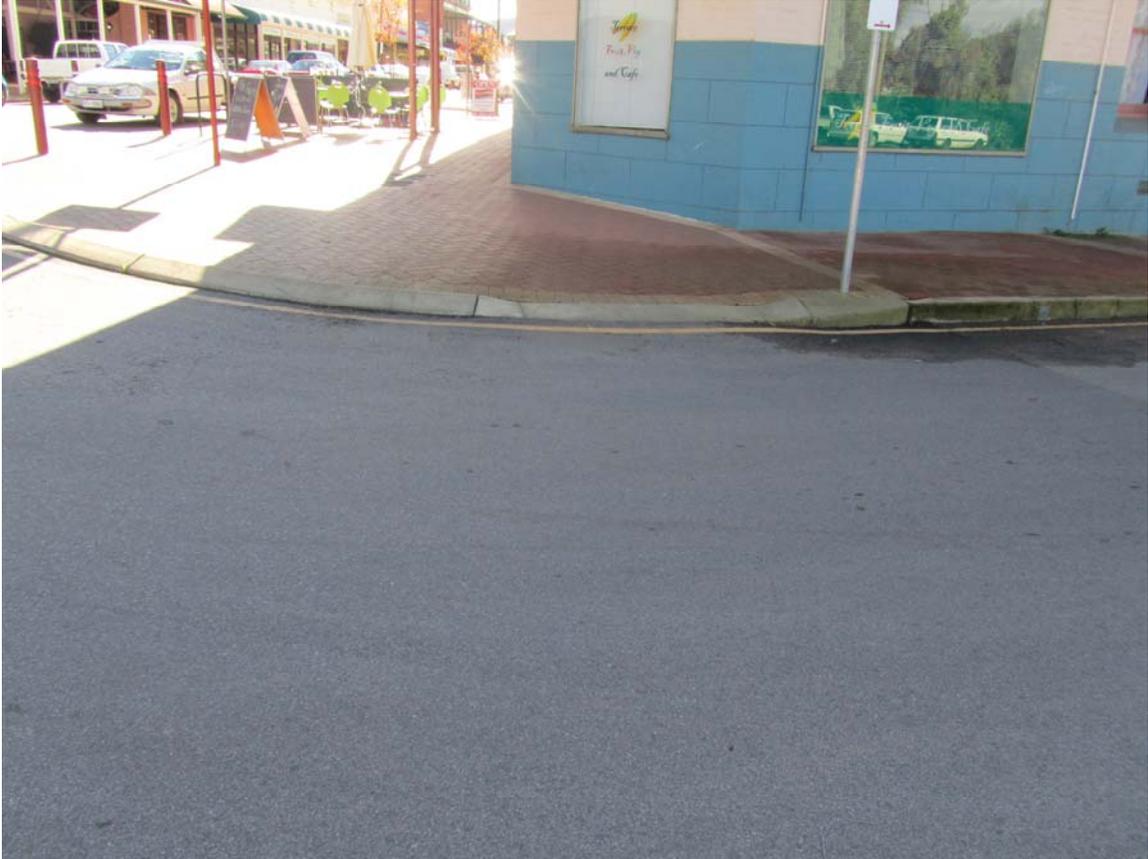
The ramp is in the wrong position and does not line up with the ramp that is needed on the other side of the road.

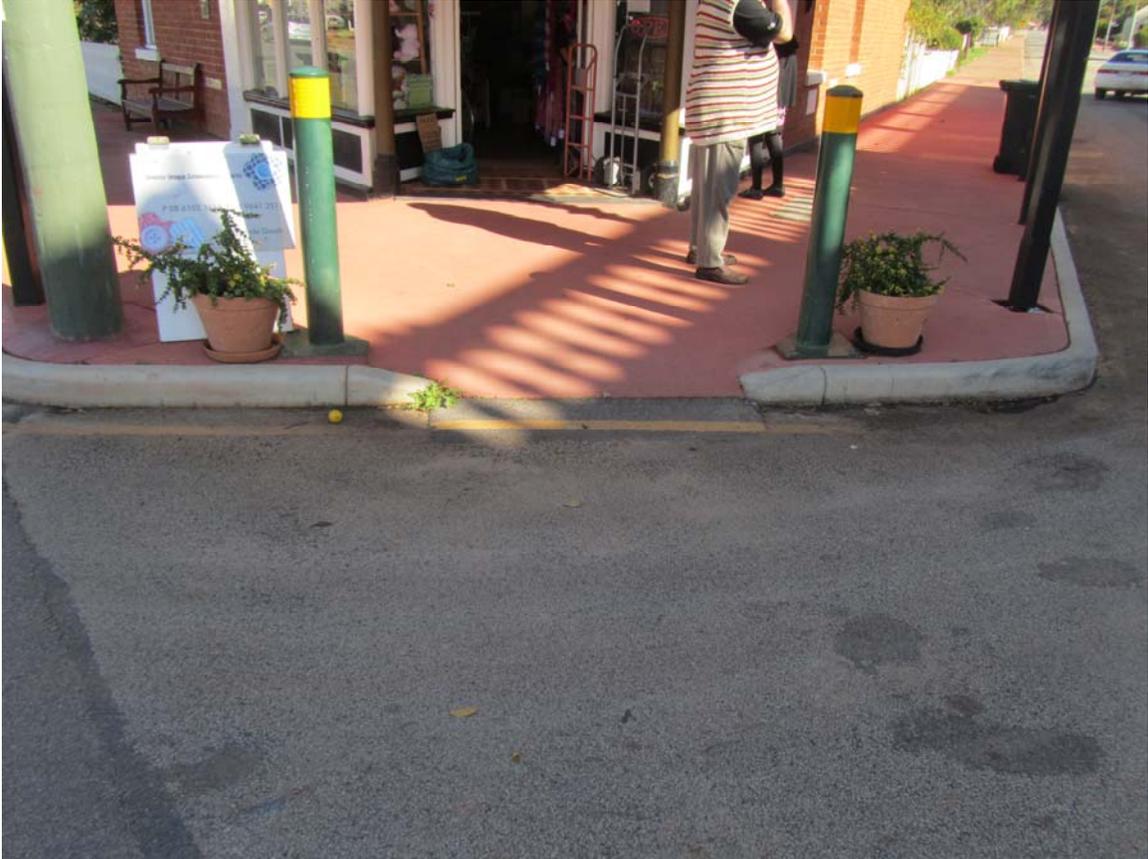
This ramp is sloped well and is in a position that users can see approaching cars.

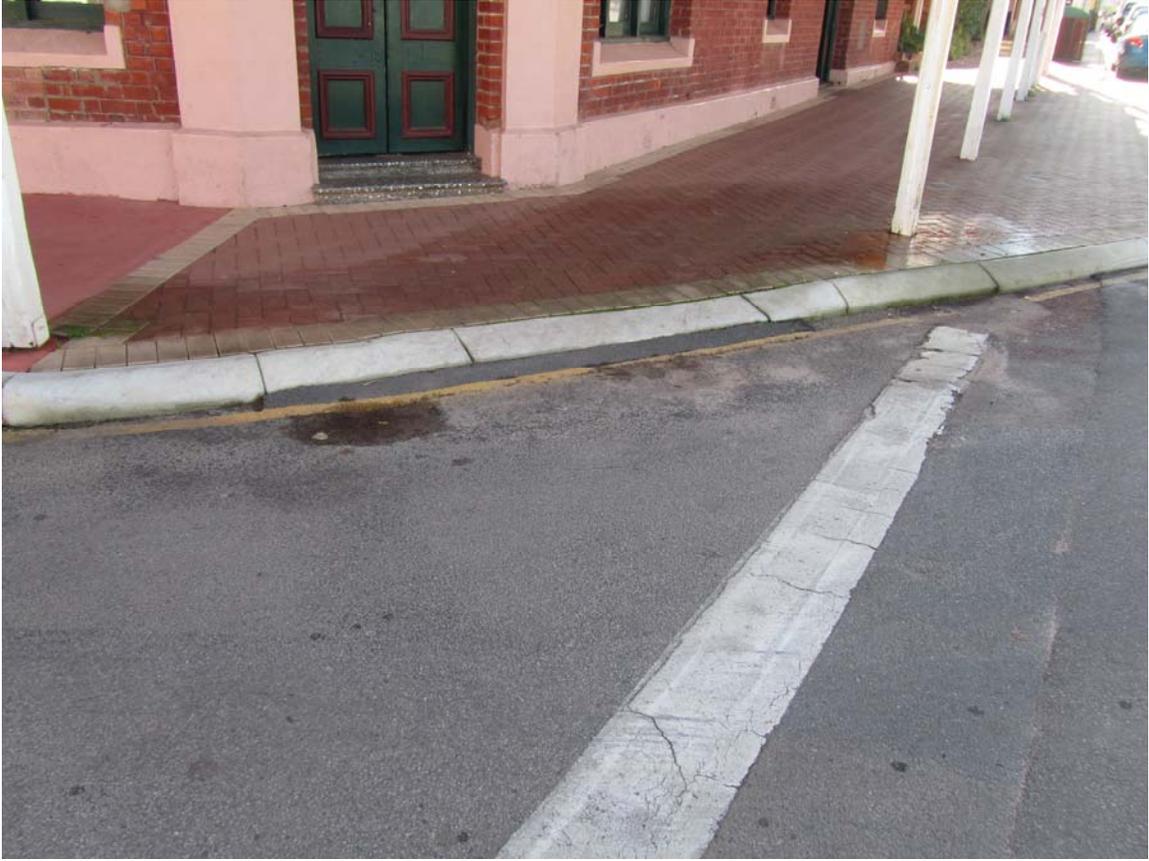
This ramp is on such an angle that users tend to roll when using this ramp.

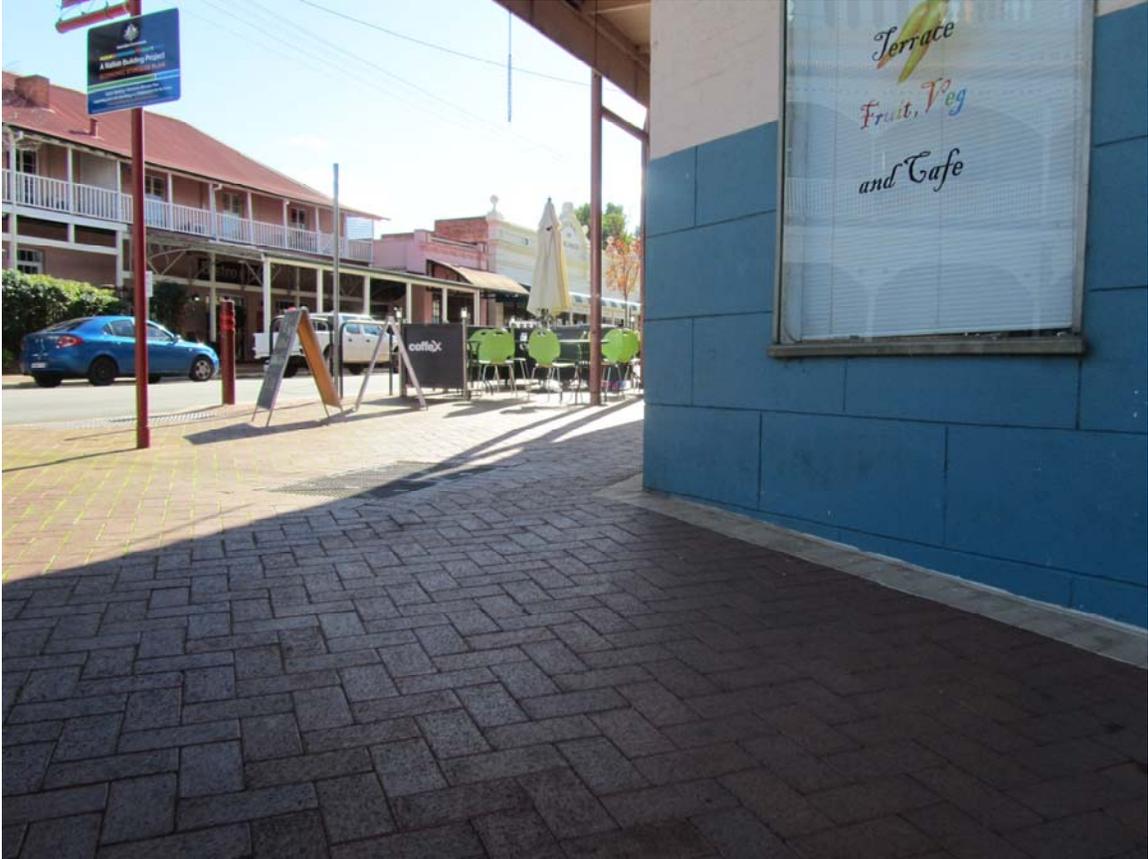
This is the view of the ramp when in the position of a person in a wheelchair. It is very difficult to see if cars are going to turn.

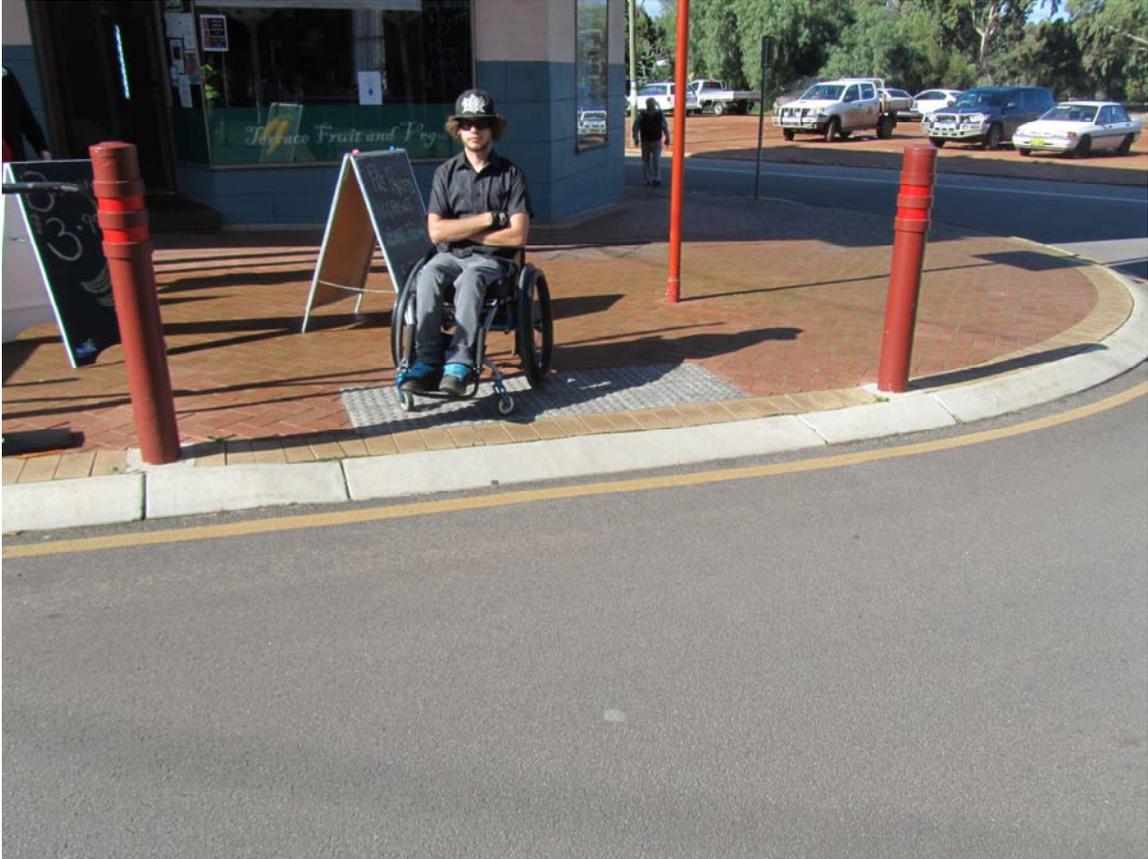
This crossing is well designed. It has the textile paving for the sight impaired as well. Shop display signs further up Avon Terrace must be 300mm in from kerb as not to restrict vision of those crossing here.

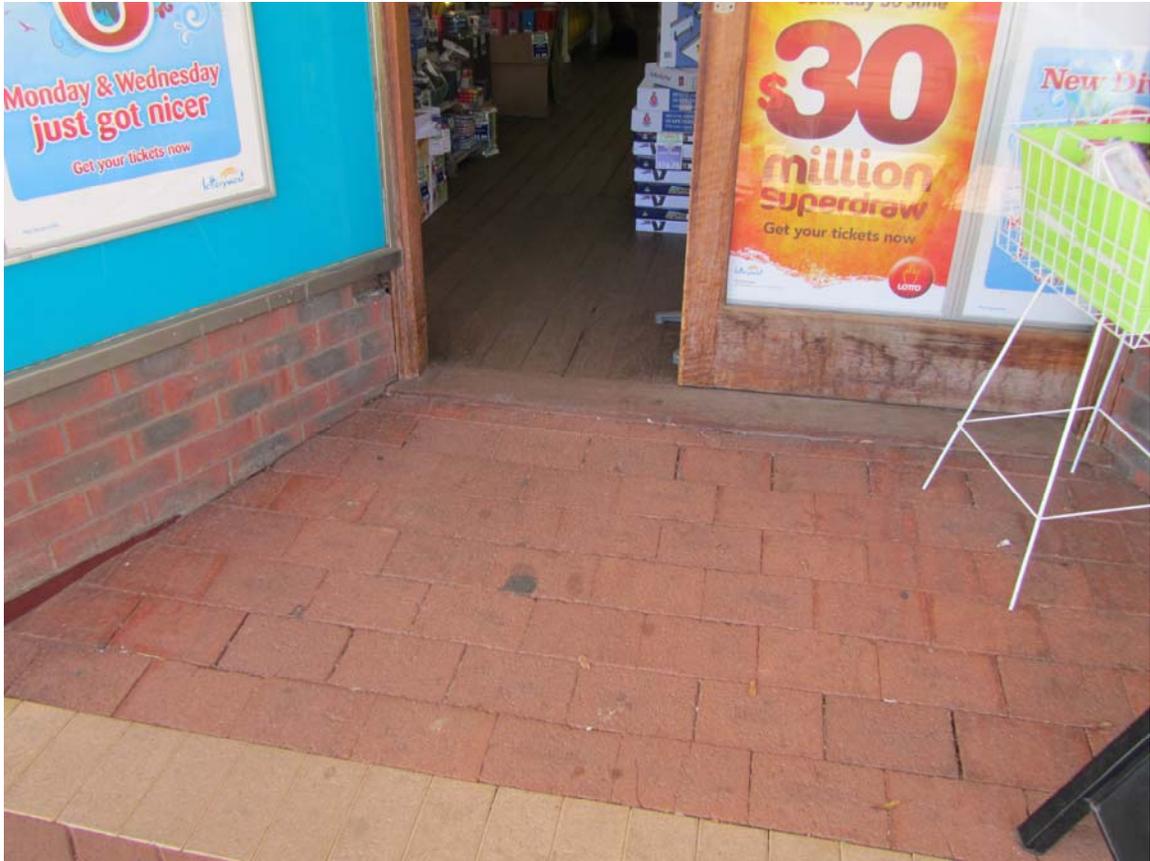
Many of the shop fronts in York are difficult for those in wheelchairs to gain access.

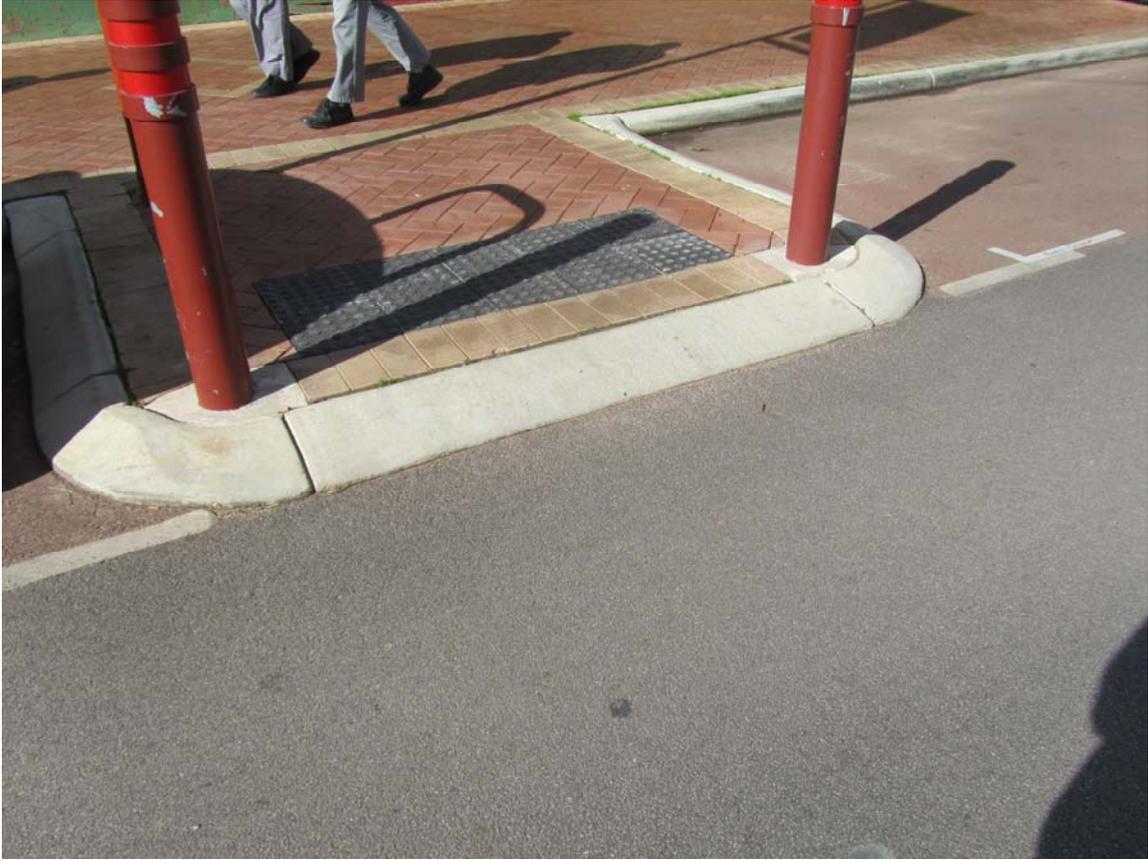
Kerbing at this crossing is too steep. When crossing here users roll onto road before getting a chance to see if a car is coming.

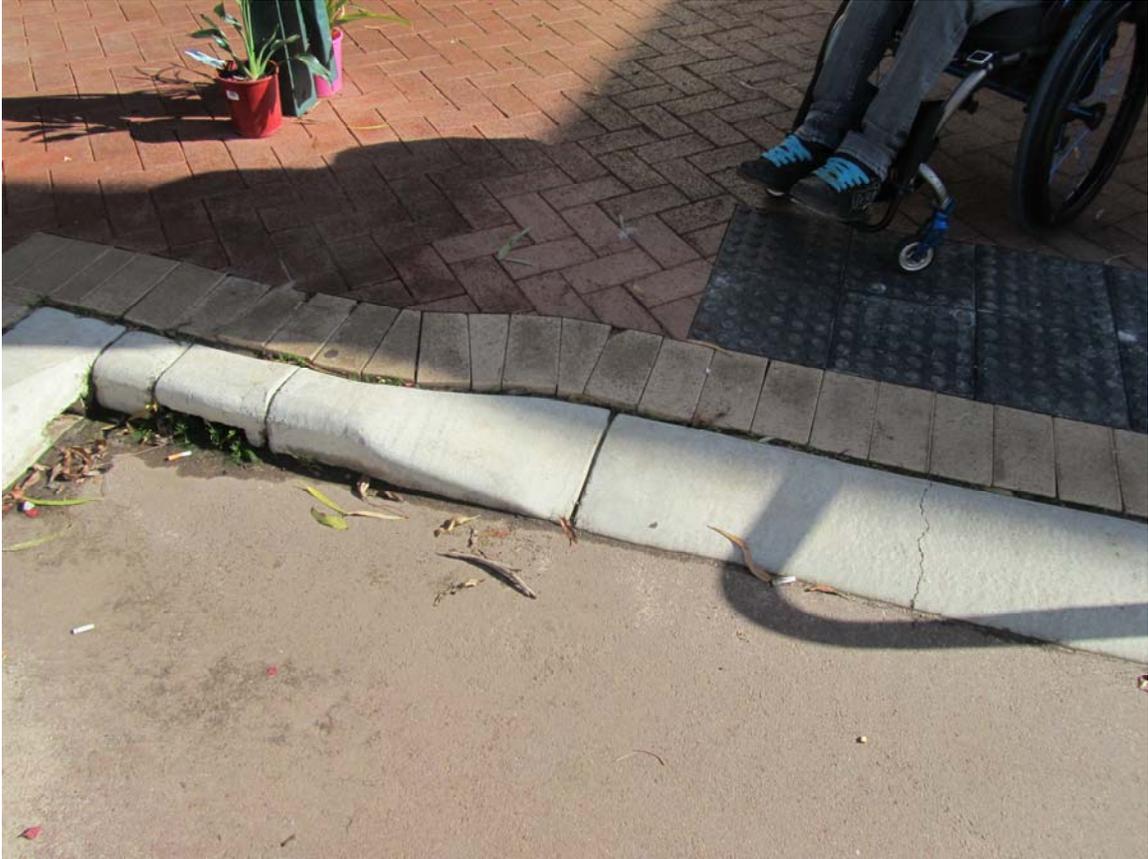
Same problem here as across the road and approx 8 pavers need to be pulled up and re-laid due to the large lip.

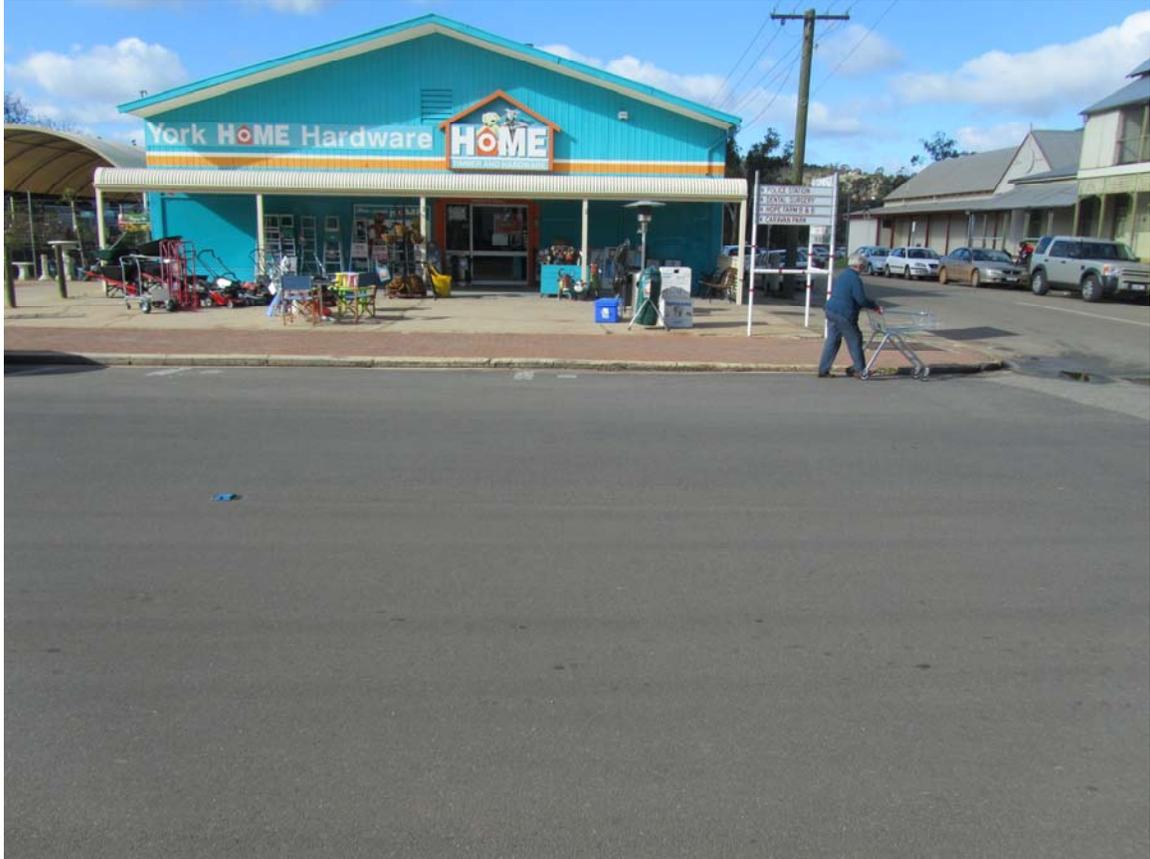
No ramp has been installed.

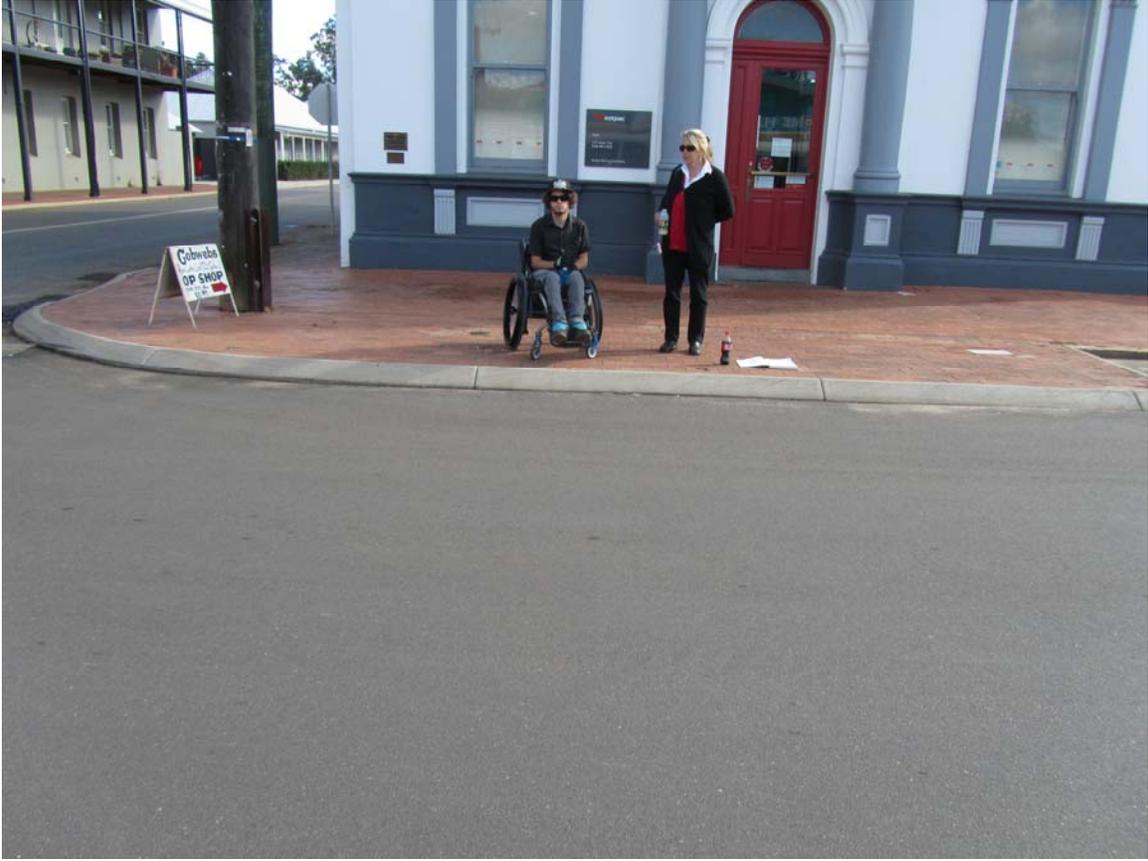
Nice big nib but no proper ramp. Kerbing too steep.

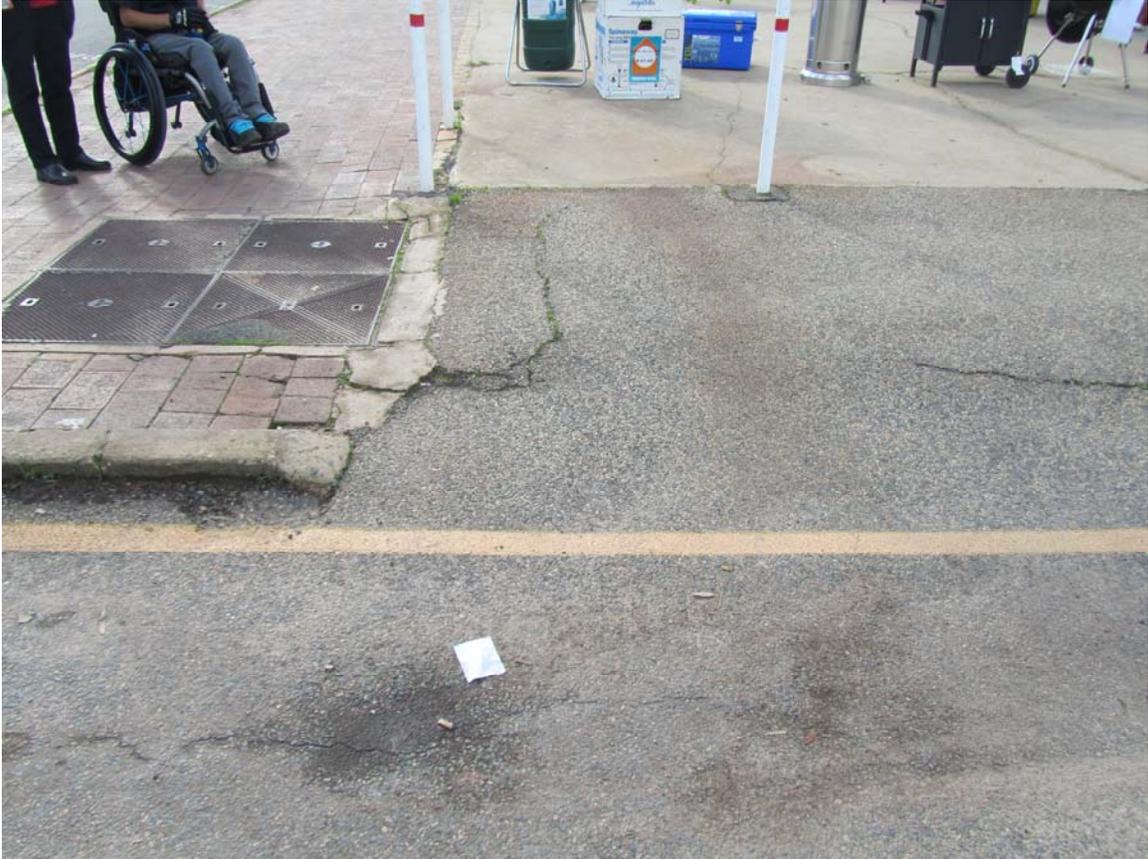
No proper ramp to cross from hardware to IGA. This sloped area does not line up with Ramp at IGA.

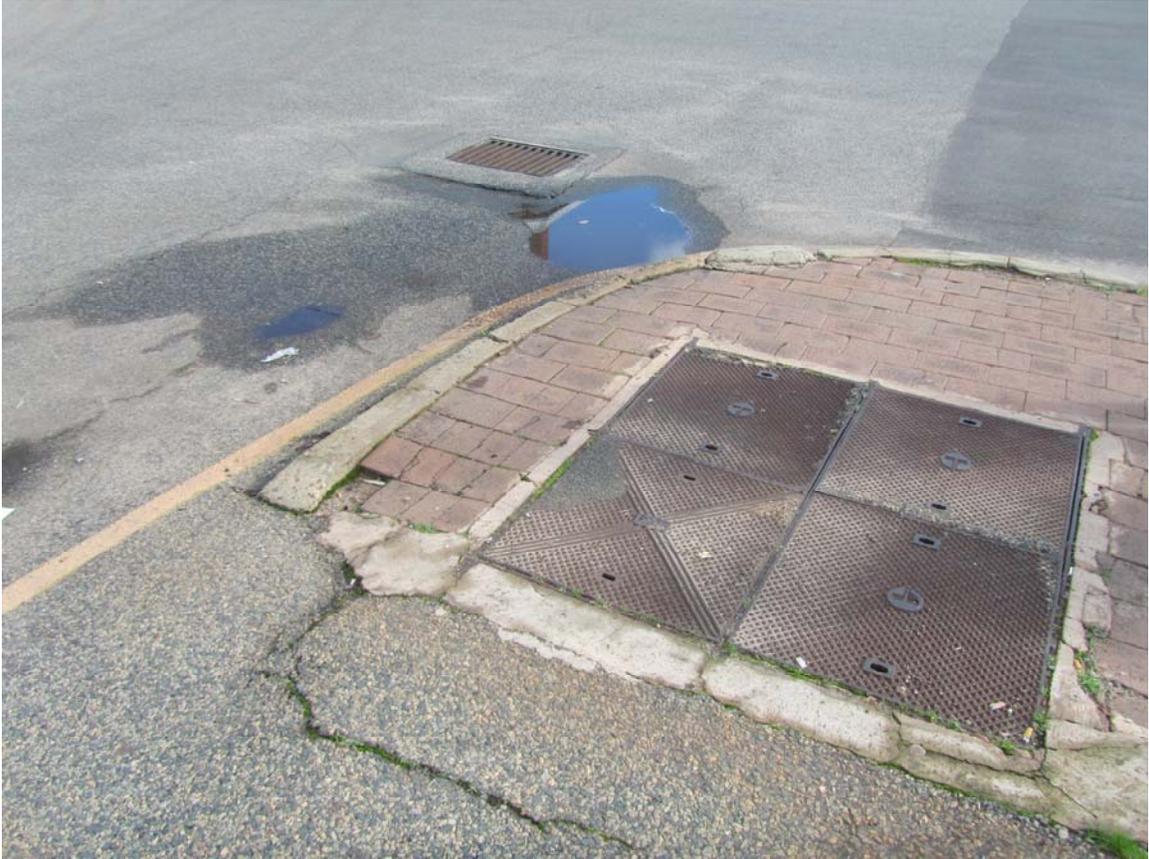
Footpath uneven and needs fixing.

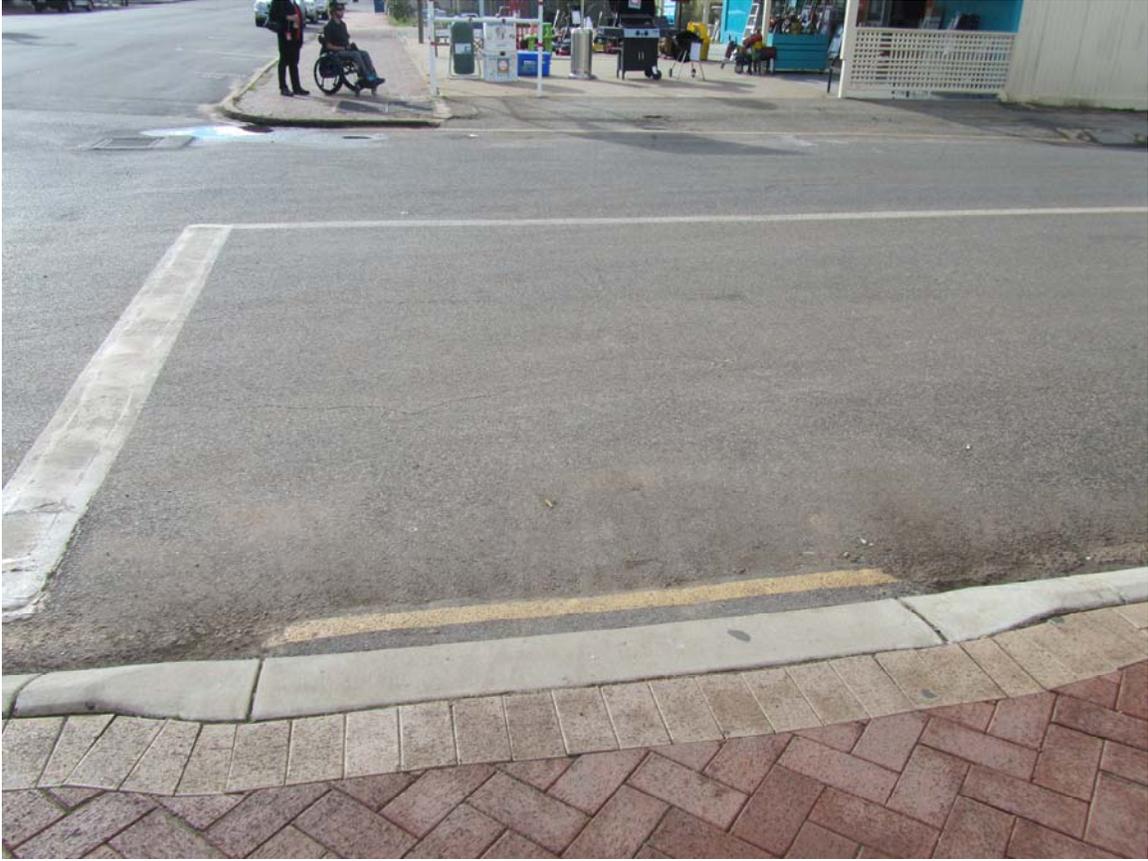
This ramp is okay.

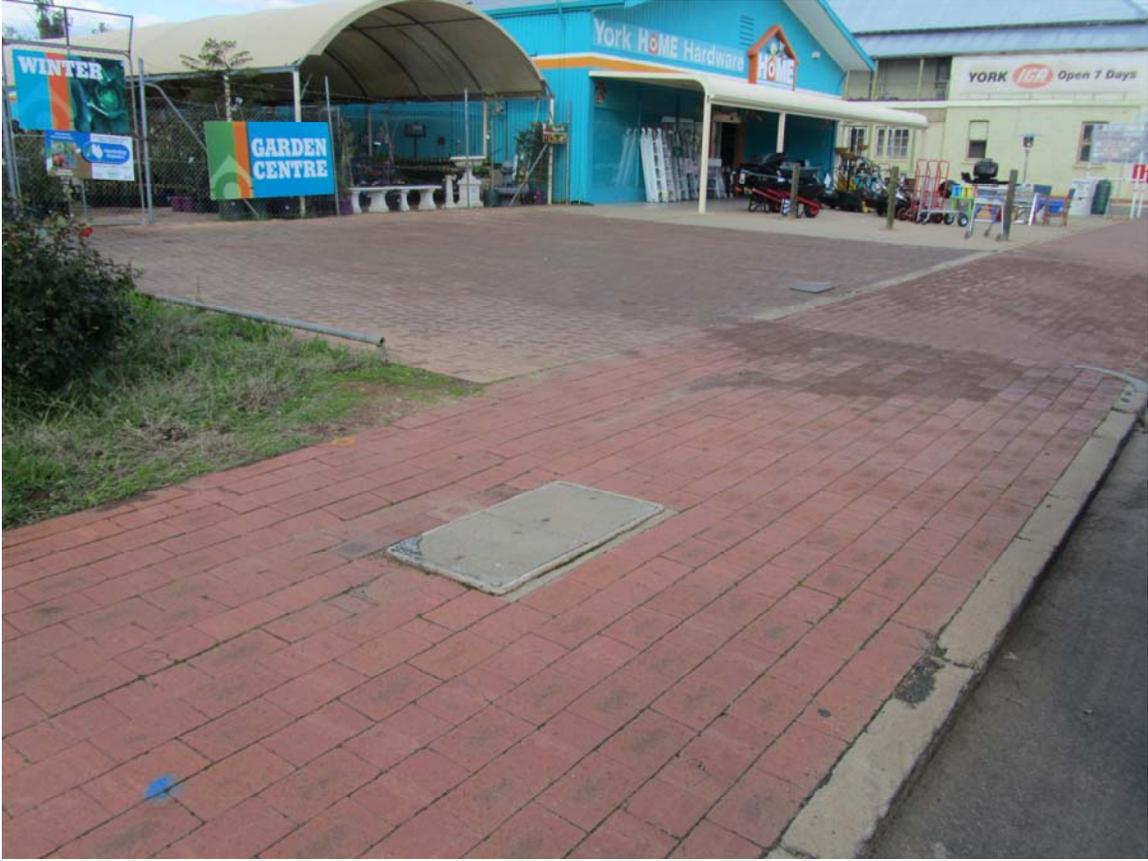
This cover is above the footpath approx 40mm.

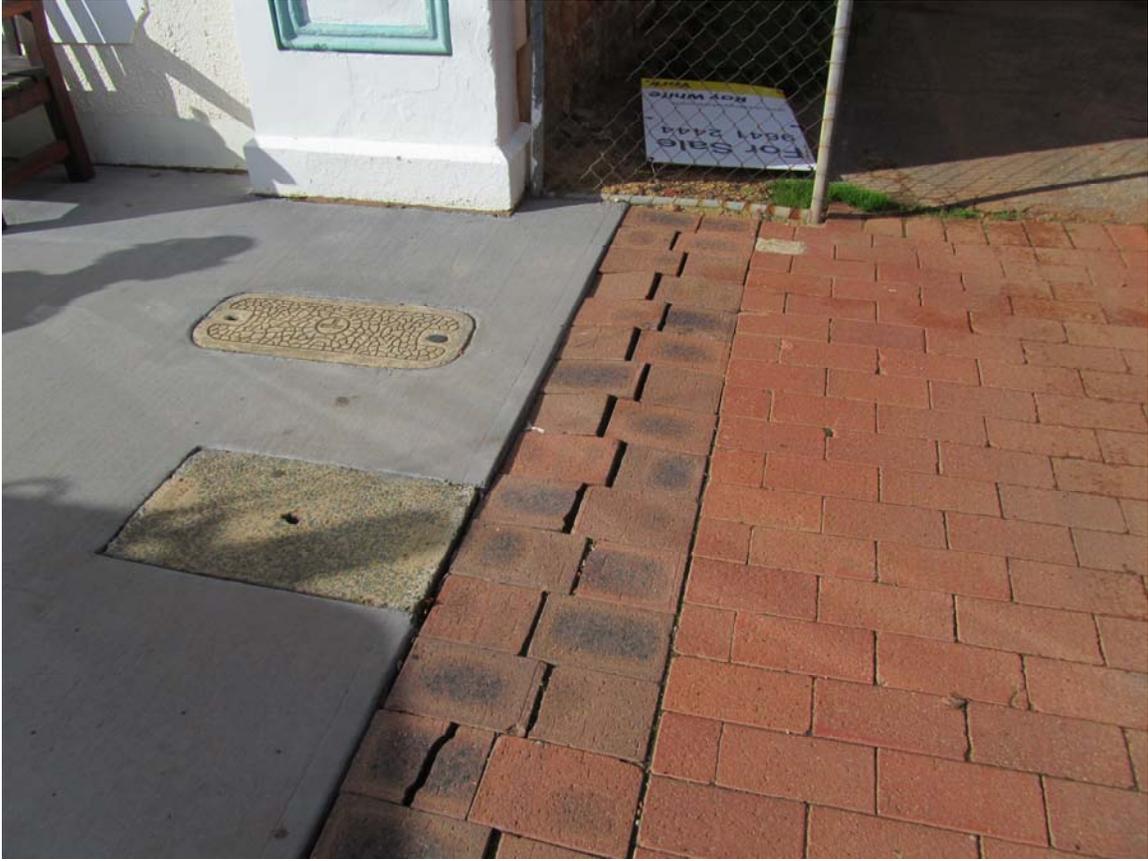
Paving north of vet before joining concrete footpath is loose and uneven.

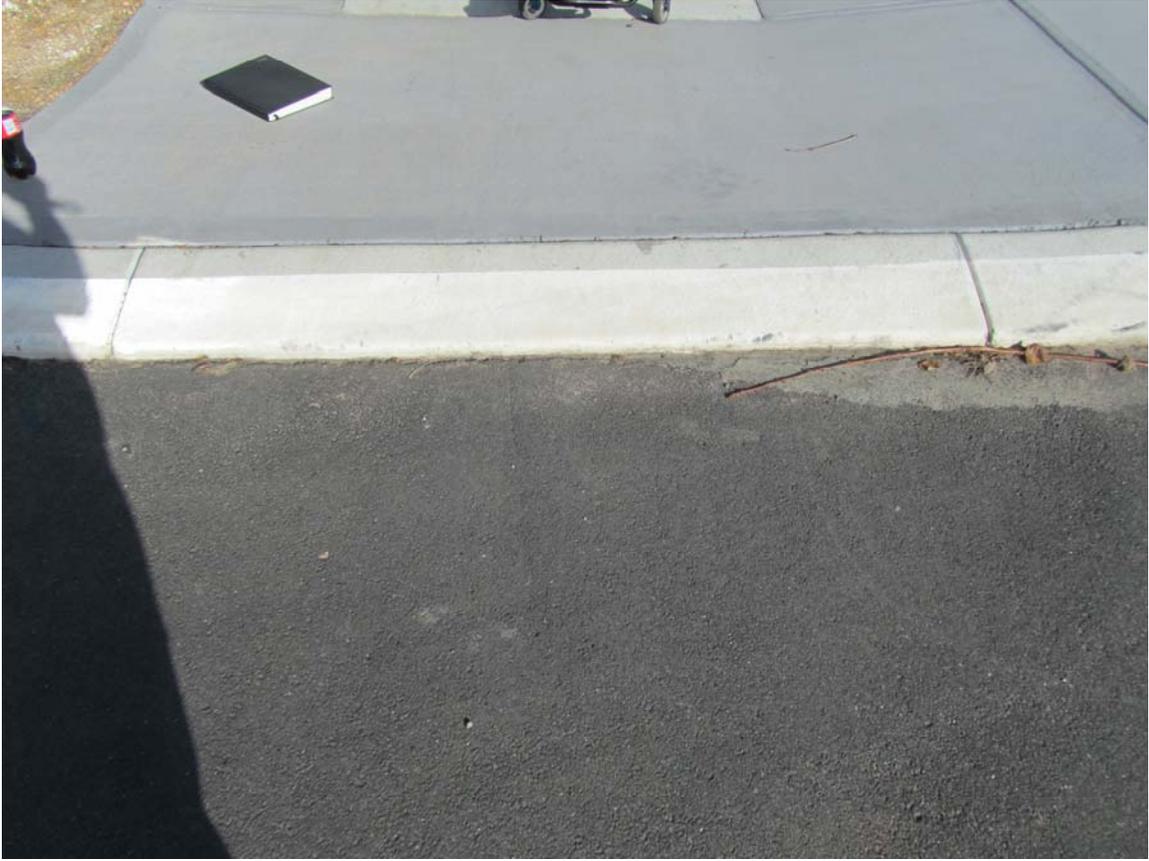
Lip on ramp here approx 40mm

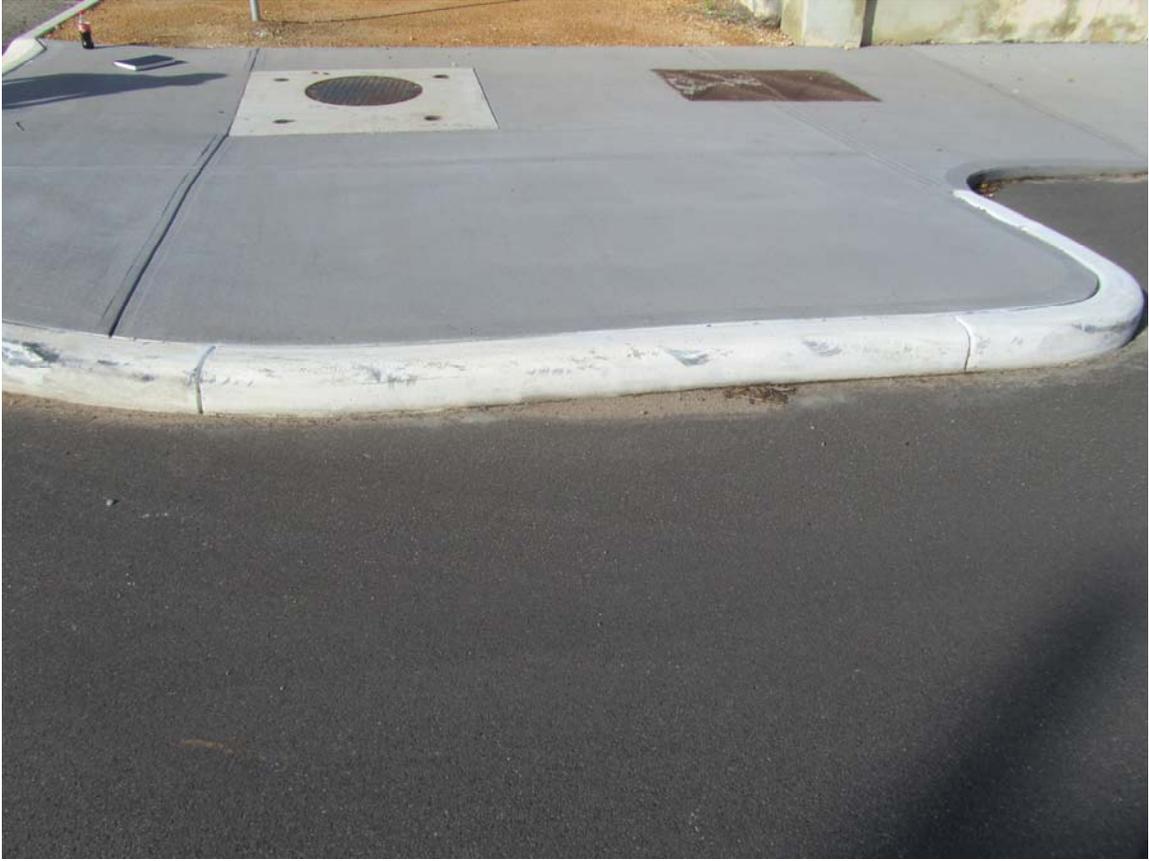
Nice nib no ramp.

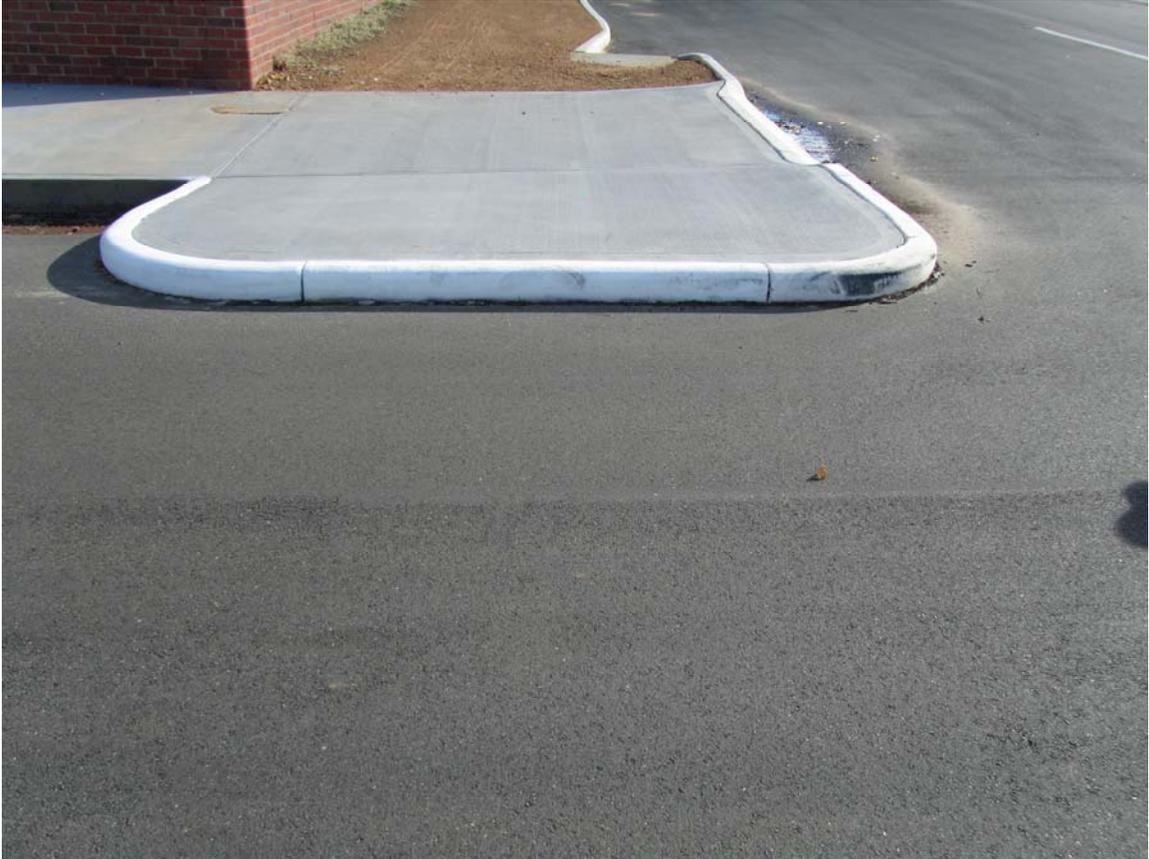
Nice nib no ramp.
