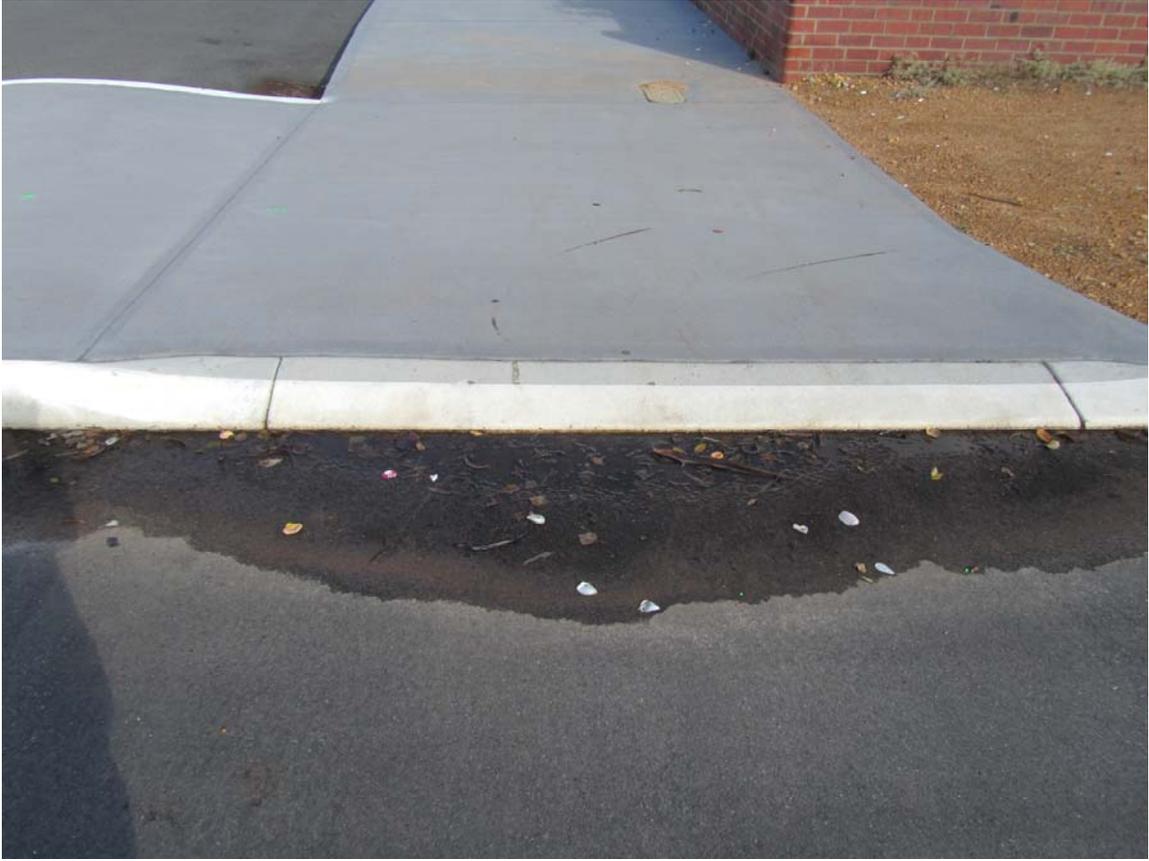
40mm lip.

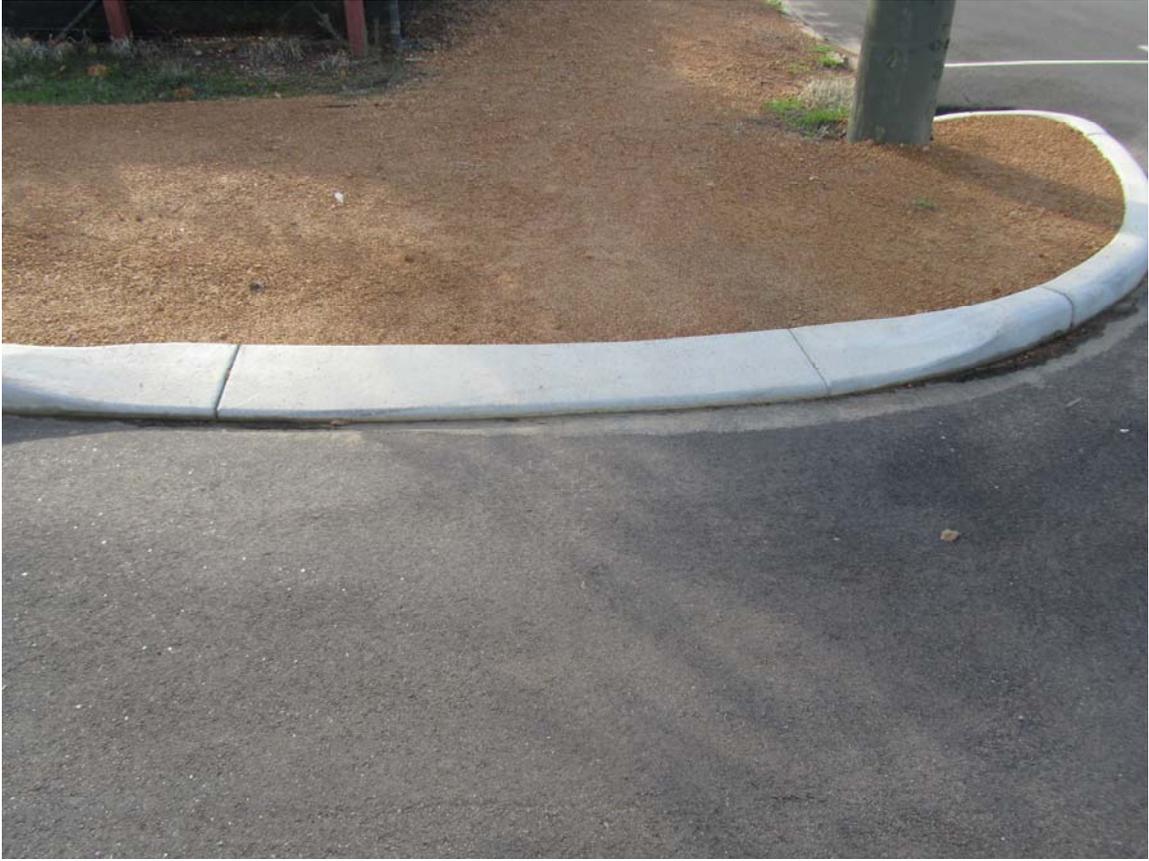
Large lip 40mm.

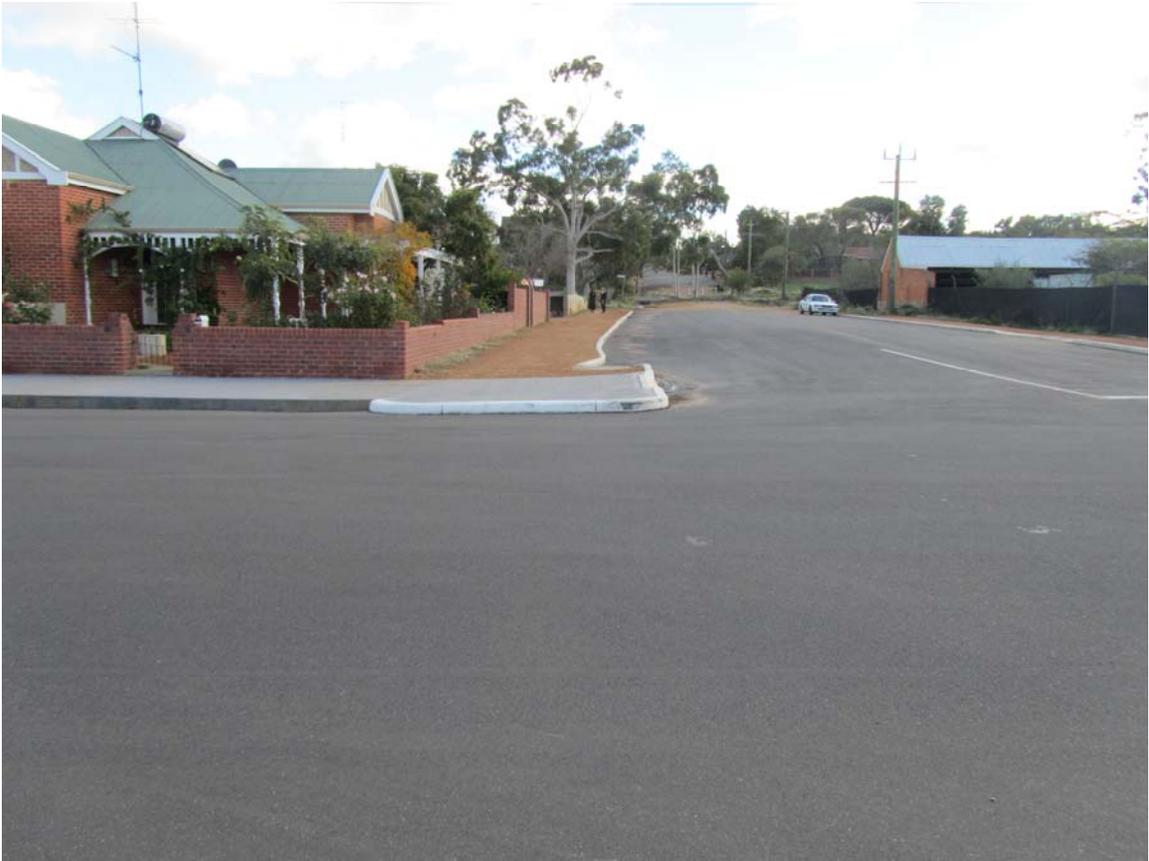
No footpath to WIFSA and problems with flooding.

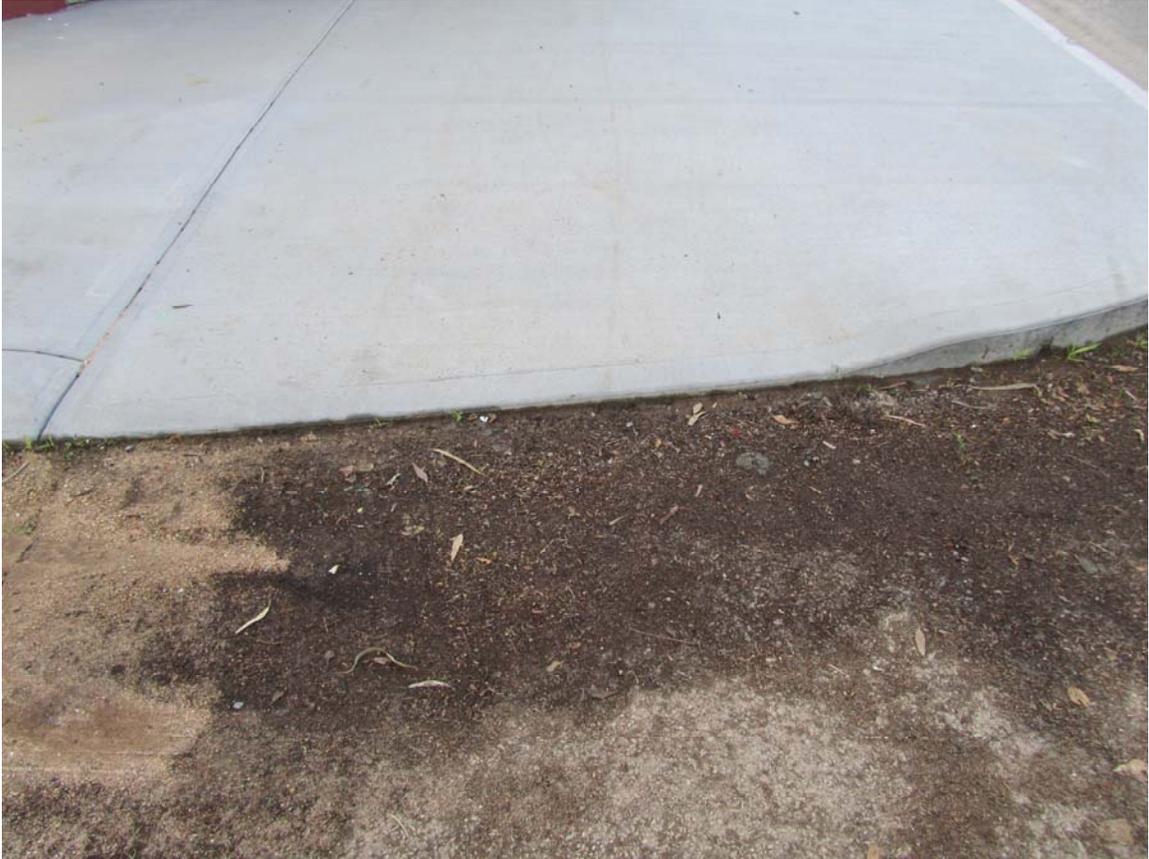
Large lip both sides of Harvey Street between Dolzy shop and old Bank of Australia.

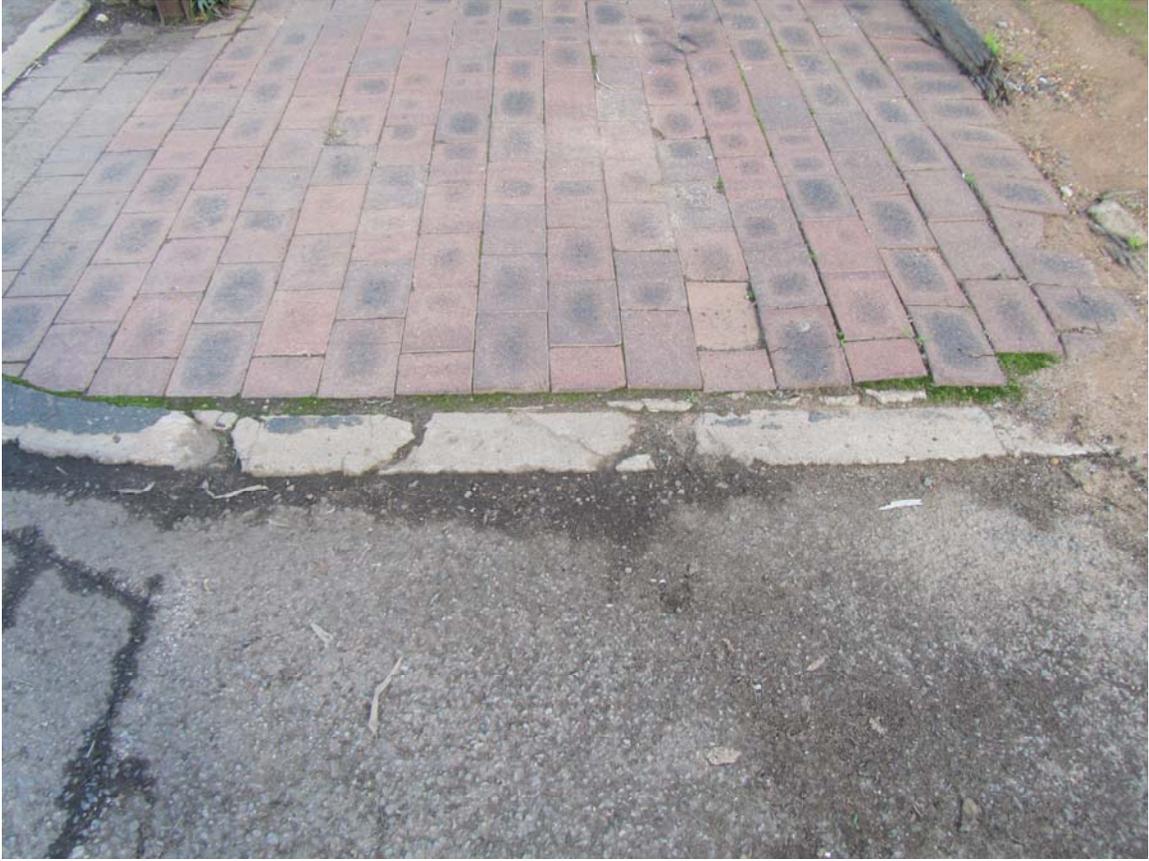
As above.

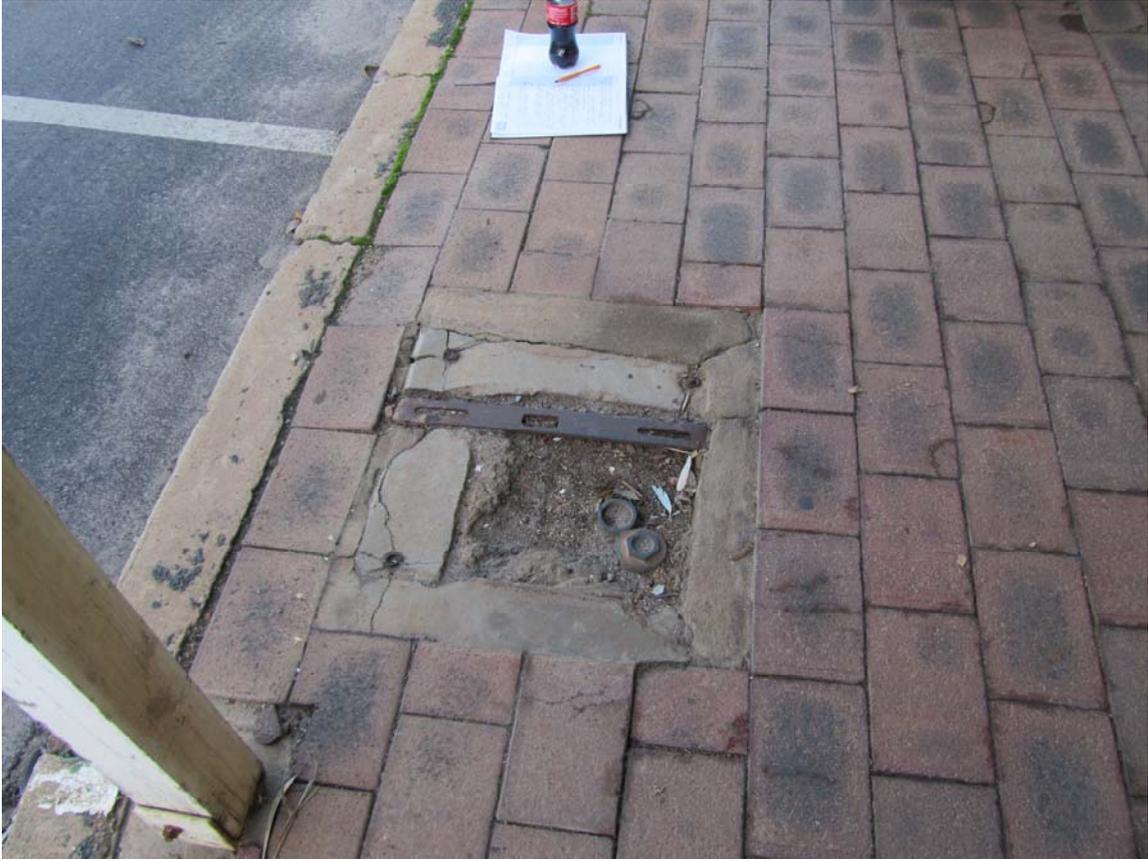
North of old fire station has pipes and holes in the paving.

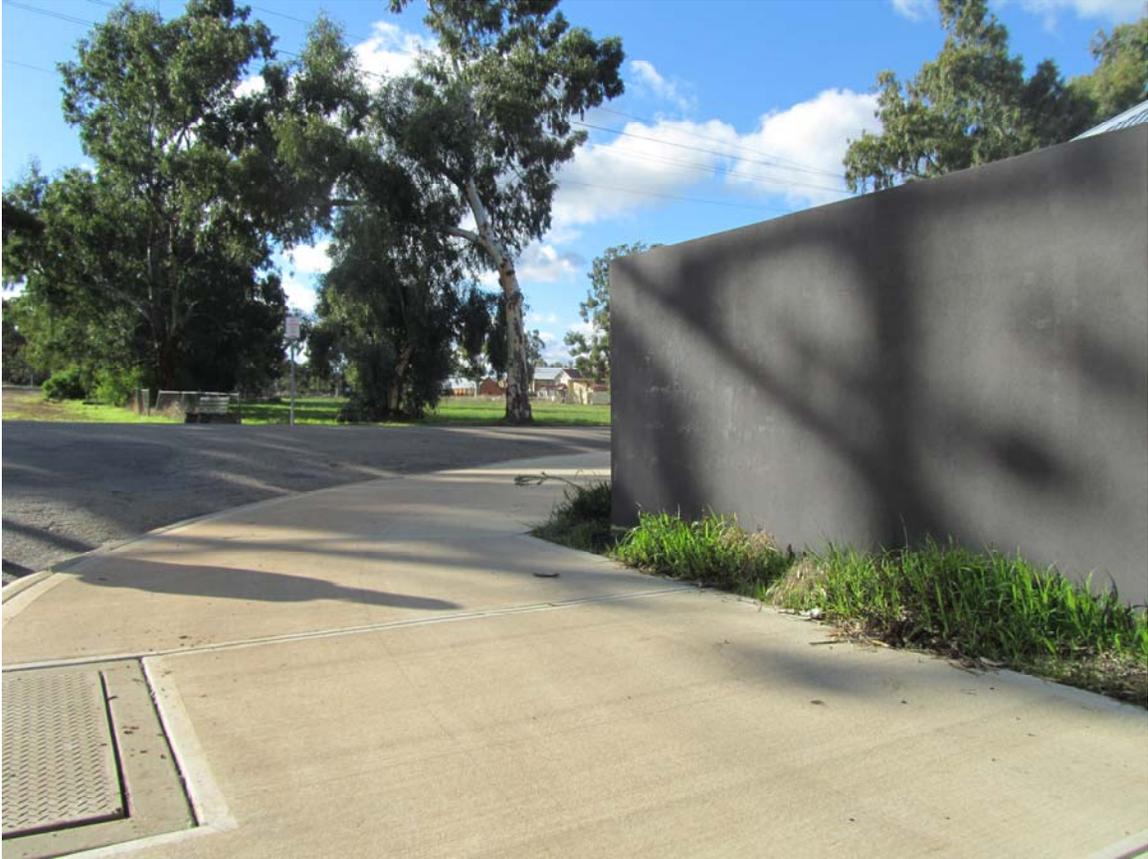
When crossing Howick Street users cross the road and hope for the best. Can not see if cars are coming at all.

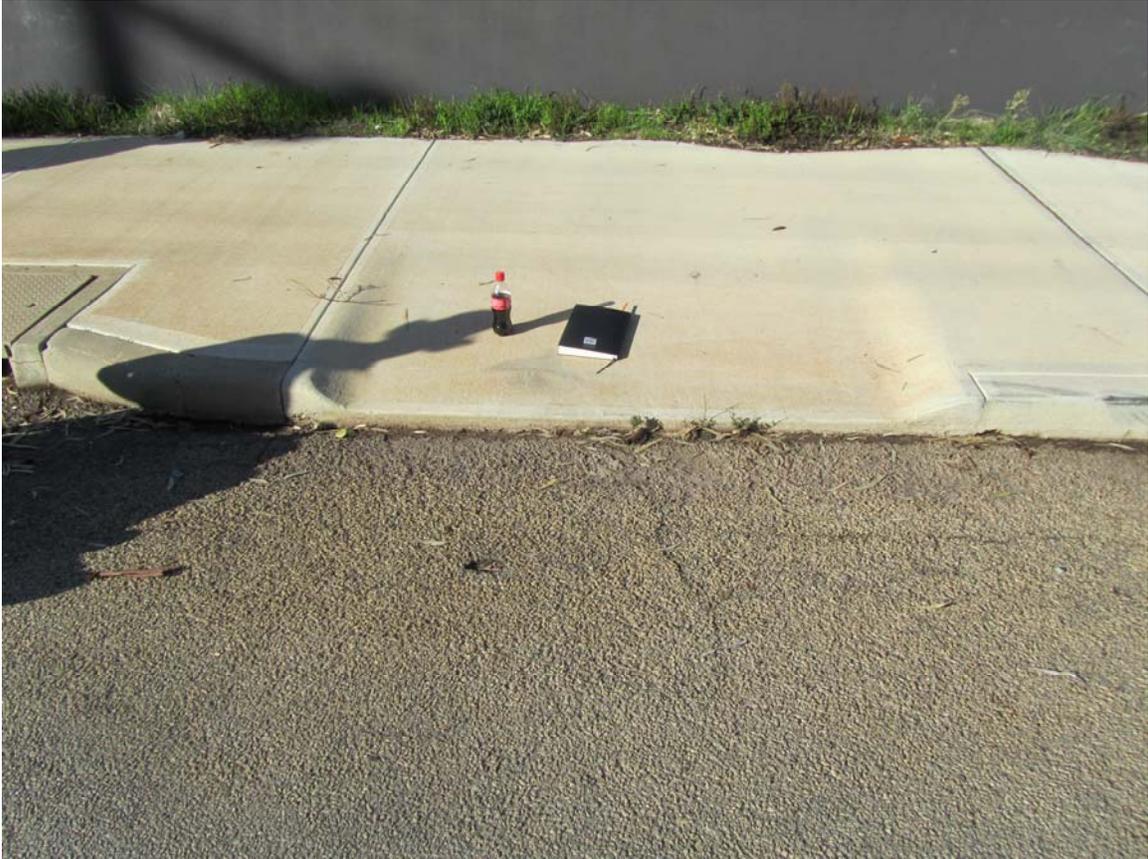
Lip here is approx 70mm. Unable to be used in a wheelchair.

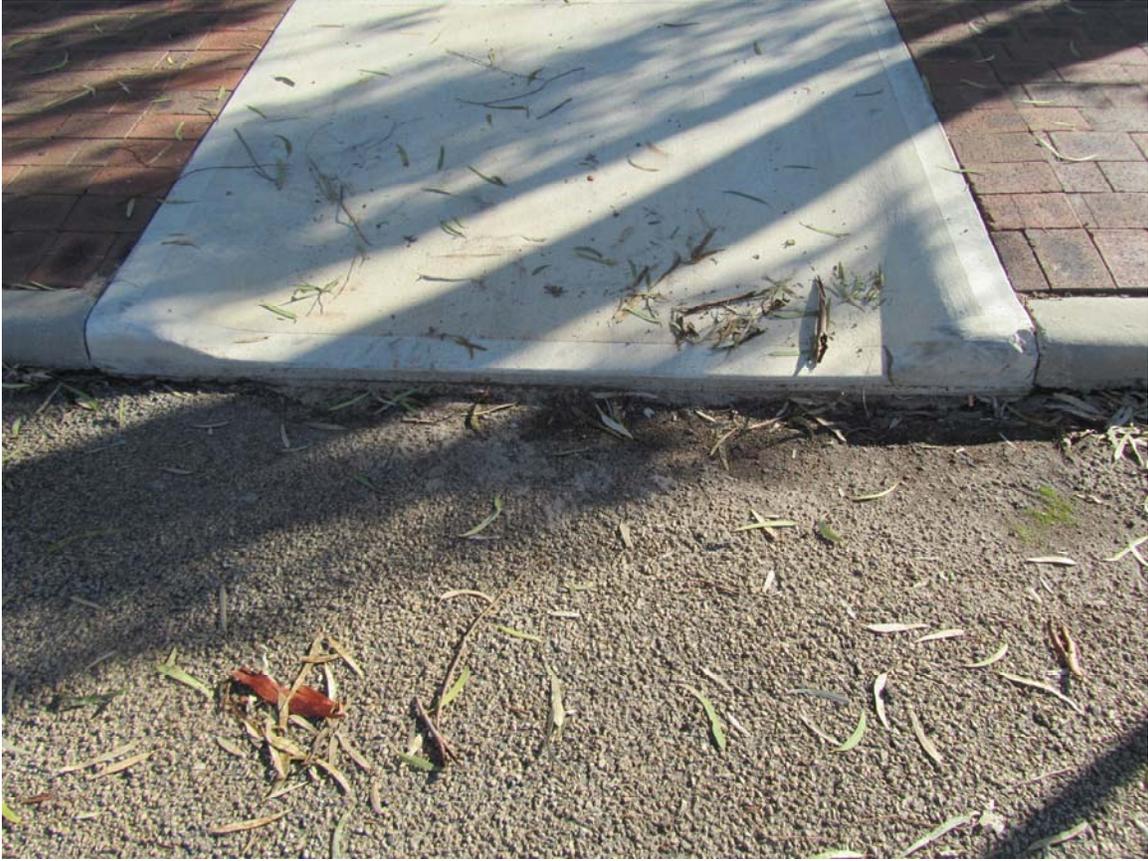
Lip this side of Howick Street is approx 80mm. Also unable to be used by a person in a wheelchair.
