MINUTES

Access and Inclusion Advisory Committee Meeting Tuesday, 12 March 2019

This report presents the outcomes of the Disability Access and Inclusion Audit undertaken by O'Brien Harrop Access for the Committee's consideration and recommendation to Council.

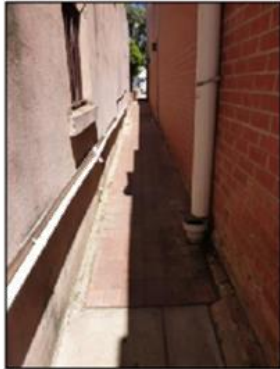
Avon Terrace – Access

Through the community consultation it was raised that there is concern as to the lack of accessible parking on Avon Terrace, particularly in what was described as a key area of use, particularly by the older community members (pharmacy, Bendigo Bank, tea shop and newsagency). It is understood, for a person requiring an accessible parking bay, they would park to the rear of the pharmacy (Howick Street car park) and would be required to negotiate the narrow Smales Lane. This laneway does not form an accessible path of travel and is not likely to enable access for people who use walkers, wheelchairs or scooters.

OHA has therefore recommended accessible parallel parking in this area of Avon Terrace be provided, ideally to the western side of the road (as parking outside IGA is to the eastern side of Avon Terrace).

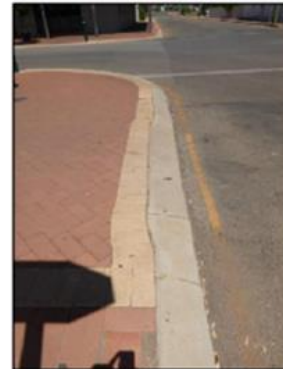
- Further, extending bitumen onto the roadway to create a kerb ramp is not a satisfactory solution to ramp the transition from the footpath to roadway. Kerb ramps are to be fully inset into the footpath, ensuring in all instances that a 1500mm deep, flat landing is preserved at the top of the kerb ramp, to allow for a 90° turn (where required).

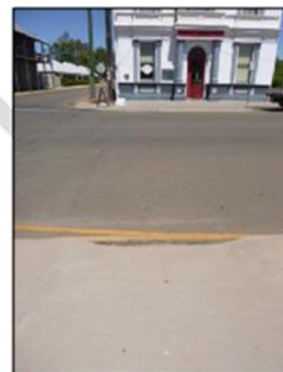
- Crossing points without specific alignment of the intended crossing point can be misleading from a wayfinding perspective for people with poor vision. AS1428.1 2009 Clause 10.7 and associated Figures states that *“the centre-line of kerb ramps and pedestrian refuges shall align across the road”* and *“top and bottom of kerb ramps shall be aligned at 90° to path of travel”*.

- Kerb ramps that have no visual difference to the footpath surface can also reduce ease of navigation for people with poor vision and can pose a significant tripping / stumbling hazard, as the ramp slope may be unanticipated by people walking along the footpath. This was particularly notable at the Macartney / Avon Terrace intersection. Further, AS1428.1 2009 Clause 10.7.2(ii) states that *“the sloping sides of a kerb ramp shall be tapered or splayed as indicated in Figures 24(A) and 24(B)”*. These figures demonstrate the sides being splayed 45°, ensuring they are traversable for transverse pedestrian traffic. At these same crossing points the sides of the kerb ramp are steep / not splayed to 45°, and can pose an unanticipated tripping / stumbling hazard, compounded by the lack of visual distinction between level footpath (grey concrete) and ramped surface (grey concrete). OHA would advocate that when re-making kerb ramps that the footpath surface is retained as the typical red brick paver, and the kerb ramp is constructed to the rigours of AS1428.1 2009 Clause 10.7 from a different material, ideally grey concrete.

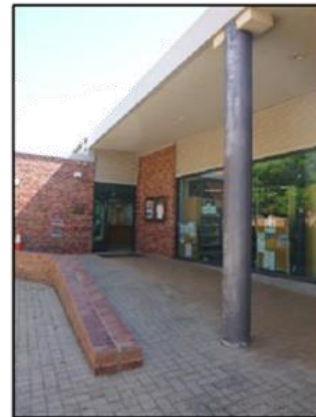
2. Shire of York Administration Building

Two on-street parallel accessible parking bays are located on Joaquina Street with direct access to the principal entrance of the Administration building. Built just short of the superseded Australian Standard requirements in terms of dimensional requirements, the accessible bays require upgrade to meet the contemporary standard, ensuring a level surface is achieved to enable a person with a disability to safely transfer in and out of their vehicle with a smooth kerb ramp transition provided to the abutting footpath.

A wide, traversable path to the entrance of the Administration Centre comprises a slope that may be challenging for people with a mobility impairment or a medical condition that depletes physical endurance. Provision of handrails along the sloped section of path is worthy of consideration as this provides additional support to community members and visitors when approaching and exiting from the main entrance.

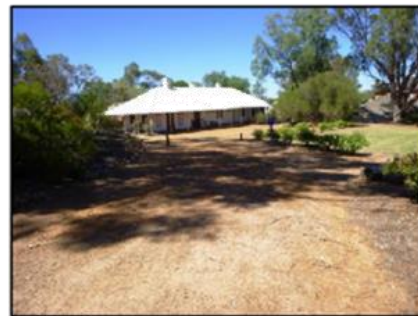
5. York Residency Museum

Given the constraints on increasing circulation spaces and levelling floors, the curator is mindful of providing the best access possible for all visitors and generally access through the rooms has been provided, either independently or with the offer of minimal assistance. We note that the museum has a staff member in attendance during operating hours.

Whilst an accessible parking space has been provided on the same (lower) level as the building, the space provided is not marked out and the ground surface is sloped and uneven. OHA has recommended that a hard stand with markings be provided at the accessible bay location with a hard path linking the new bay to the paved forecourt.

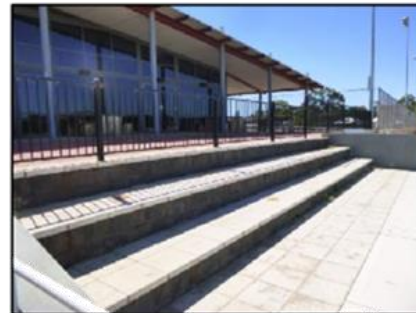
6. York Recreation and Convention Centre

Seven accessible bays have been provided, designed and constructed to the contemporary 2009 parking standard.

The bays are set away from the entrance and with no elevated signage they may not be evident to any person driving into the carpark. Elevated signage is recommended at the accessible bays as well as provision of bollards in the shared areas.

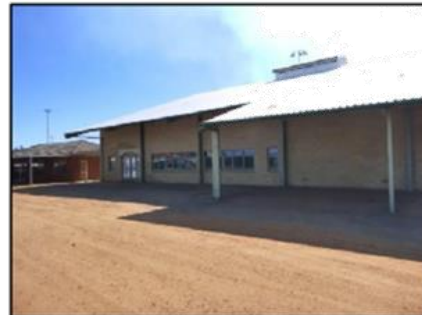
There is no formalised parking associated with this building. It is recommended that, to provide equal opportunities for people with disability, consideration be given to creating one accessible bay under the covered hardstand adjacent the building with an accessible path of travel to the netball courts.

The entrance door has a step externally and a lip internally, both of which will require ramping to remediate.

The upstairs room is accessed via a stairway with many non-complying elements including open risers, non-provision of warning strips on stair nosings, non-provision of warning tactile ground surface indicators and a balustrade style handrail which does not meet contemporary requirements. As this upper area is relatively small and currently leased to a dance studio it is understood in general participants and staff would require a level of mobility that would enable them to negotiate a set of stairs. The Shire should monitor use of this space and where required the current stairway should be replaced with a stairway that complies with all elements of an accessible stairway. OHA has not considered it necessary to recommend a lift as other more accessible spaces are available within the Shire should a lessee require an accessible space.
