MINUTES

Access and Inclusion Advisory Committee Meeting Tuesday, 12 March 2019

This report presents the outcomes of the Disability Access and Inclusion Audit undertaken by O'Brien Harrop Access for the Committee's consideration and recommendation to Council.

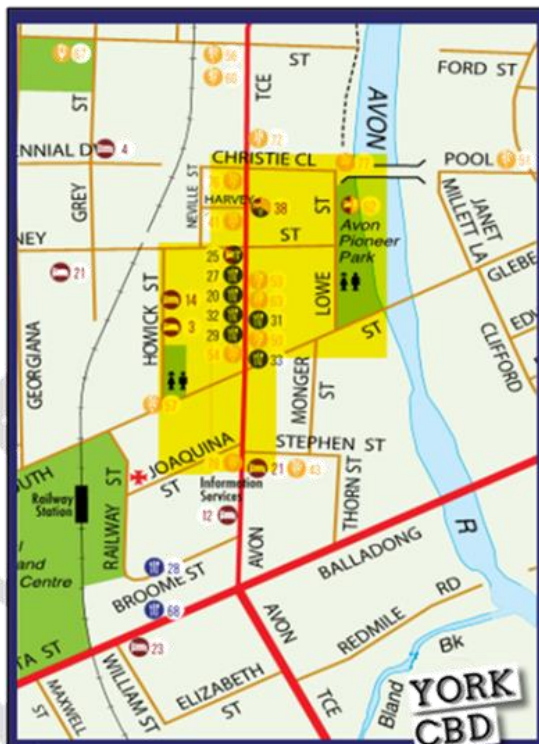
- Access for people who are scooter users, via gravel / uneven paths, particularly from Balladong Village.
- The reported difficulty of people attempting to cross Avon Terrace (due to the frequency of vehicles and challenge of crossing the relatively wide road), particularly in the heart of the CBD.
- Non-provision of flush or kerb ramped crossing points at CBD intersections.
- Lack of accessible parking on Avon Terrace and the physical constraints (due to distance) and physical barriers (associated with Smales Lane next to the pharmacy) associated with any person attempting to move between the accessible parking in the Howick Street car park and Avon Terrace amenities.

In OHA's assessment it is confirmed that each of the broad issues raised through the community consultation, as described above, are valid.

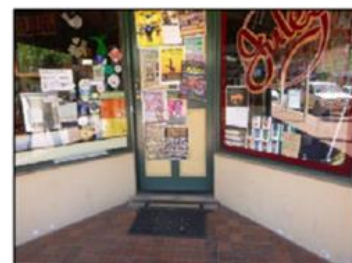
In addition to the above, the Shire raised the issue of the various heights of steps at shop fronts, and the challenge in providing access options into shops for people with disability, including people who are aged and who use mobility devices.

OHA would recommend the Shire explores working with shop and business owners to develop a guideline for shop /business access options that will improve access into Avon Terrace goods and services. For example, a maximum threshold height at which a shop /business owner could install a semi-permanent or portable ramp and suppliers of such ramps (see below). The Shire could explore whether they would accept shop owners installing threshold ramps at shop doorways, particularly in the instance the step may extend into the footpath. Examples include the [Raven Threshold Ramps](#) and [Tyrex Ramps](#).

OHA would advocate that portable ramps installed at shop fronts do not exceed 1:10 gradients and all safety measures are considered, such as protecting pedestrians from tripping on ramp sides.

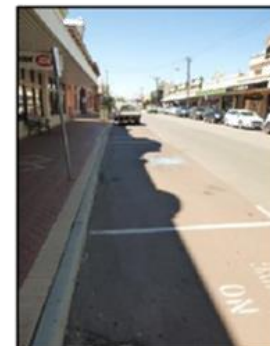
As described above, it is recommended additional accessible, parallel parking bays are provided on Avon Terrace. There are specific requirements for accessible, parallel parking bays and OHA refers the Shire to the AS2890.6 2009 requirements for parallel bays.

The Shire could consider line marking accessible parking at the road level, noting to provide an accessible parking bay with sufficient safe width to facilitate a vehicle transfer, the accessible bay is to be 3200mm wide (and thus additional protection to the rear of the bays should be considered). Where street-side parallel accessible parking bays are required, a kerb ramp is also required.

The parallel, accessible parking could also be raised to footpath level (i.e. the parking bay and adjacent footpath (shared area) are at the same level). Care would need to be taken to ensure the footpath width is however not compromised if this approach was adopted in the York CBD.

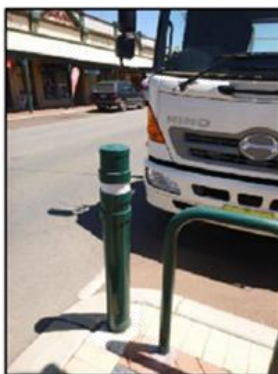
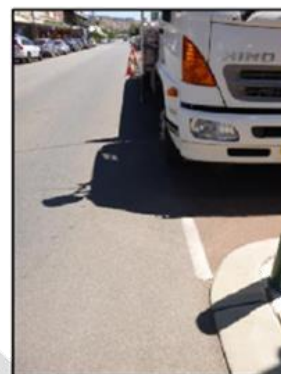
Avon Terrace – Directional TGSIs

enter the roadway in order to visually assess whether it is safe to cross the road. The risk associated with this is the gradient of any ramp, that will increase the momentum of a wheeled mobility device user as they descend the ramp, and people who use a wheelchair (or scooter), as they sit to middle/rear of the mobility device, therefore their device will be on the roadway before they will have clear vision of any oncoming vehicle traffic.

Please be mindful that OHA are not qualified in road engineering, and these barriers are observational only and any solution to address the barriers must be professionally executed by an appropriately qualified and experienced engineer.

People who are blind or have significant vision impairment may benefit from the provision of directional tactile ground surface indicators (TGSIs) as a wayfinding strategy to the midblock crossing points on Avon Terrace. Install a 600-800mm wide band of directional TGSIs set perpendicular to the path of travel (i.e. footpath). Extend the directional TGSIs from the building line across the full width of the footpath to abut with the top of the kerb ramp (at midblock crossing points) or if a flush crossing, the warning TGSIs. Ensure the band of directional TGSIs are to the design and placement requirements of AS1428.4.12009 Clause 3.2 and in the required luminance contrast to the underlying red brick pavers as per AS1428.4.1 Clause 2.2.

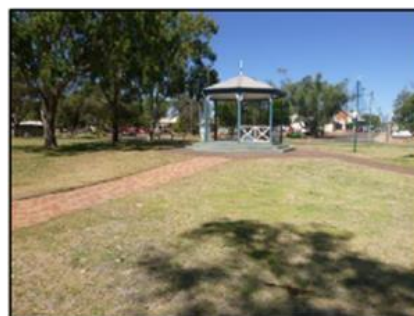
4. Avon Park

Avon Park is an important destination for York residents and visitors. It is understood the park will undergo a refurbishment and upgrade, with an objective to both improve the river edge, but also the park amenity, for all users.

Key for the upgrade to this park is the provision of an accessible path of travel to key park amenities and the provision of accessible park amenities such as accessible seating, barbeques, picnic tables and play elements. Not all park amenities need to be accessible, but it is recommended the Shire provide a selection of accessible amenities, perhaps clustering them together (particularly in the picnic and play areas).

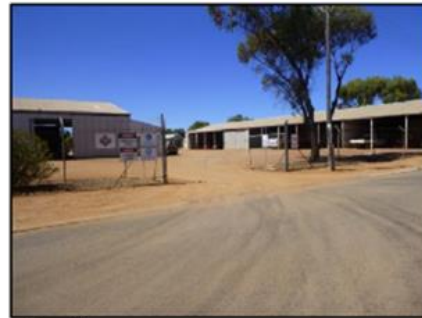
9. Shire of York Depot

The Shire of York Depot is a restricted site for members of the public and OHA have been advised that there is a short-term plan to install an electronic gate as the whole of site is considered to operate in the same manner as a construction site with robust occupational health and safety restrictions. We have been informed that currently where a staff member is required to meet with a member of the public with a disability an alternative location is sourced. Currently and in the future there is no necessity for

members of the public to enter the site and when the electronic gate is installed it will not be possible for members of the public to enter the site, without an invitation /supervision.
