### **APPENDIX 3 – STRUCTURAL ENGINEER'S REPORT**

Re: 17 Redmile Rd York

As requested, an inspection of the residence located at 17 Redmile Rd was carried out to examine its condition and comment on the structural stability of this building

# PROPOSED DEMOLITION OF ROSEMARY COTTAGE LOT 12 (17) REDMILE ROAD, YORK

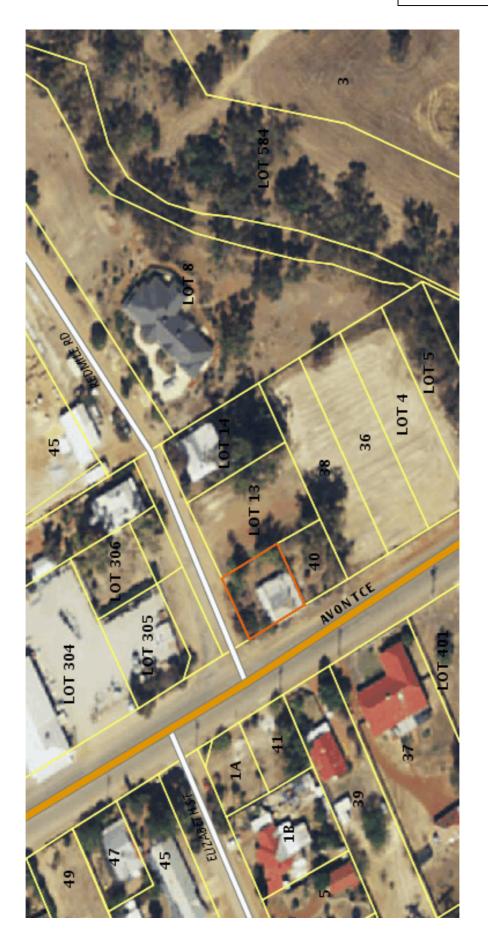
# PHOTOGRAPHS

My inspection found the building to be in an advanced state of decay. The masonry walls are severely distorted. It is evident that major cracking has been occurring as a result of foundation movement over many years. This building is built an area of land that has a history of being unstable.

The west wall of the cottage facing the Great Southern Highway leans outward at a noticeable angle. This perception is magnified by the collapsing floor that runs downhill to the wall.

The North wall in the bedroom bulges inward due to the failure of its foundations.

The concrete floor of the kitchen is fragmented and heaving and the chimney is cracked.

In summary this building is in an extremely poor condition that renders it unfit for habitation.

The decision to remove or attempt repairs is a commercial decision however in its present state I recommend it be declared a restricted access site as there exists significant potential for collapse in the event of seismic activity.
